Techniques for the Seismic Rehabilitation of Existing Buildings

FEMA 547/2006 Edition

Rutherford & Chekene (R & C) Consulting Engineers (Subconsultant) under contract with National Institute of Standards and Technology (NIST).

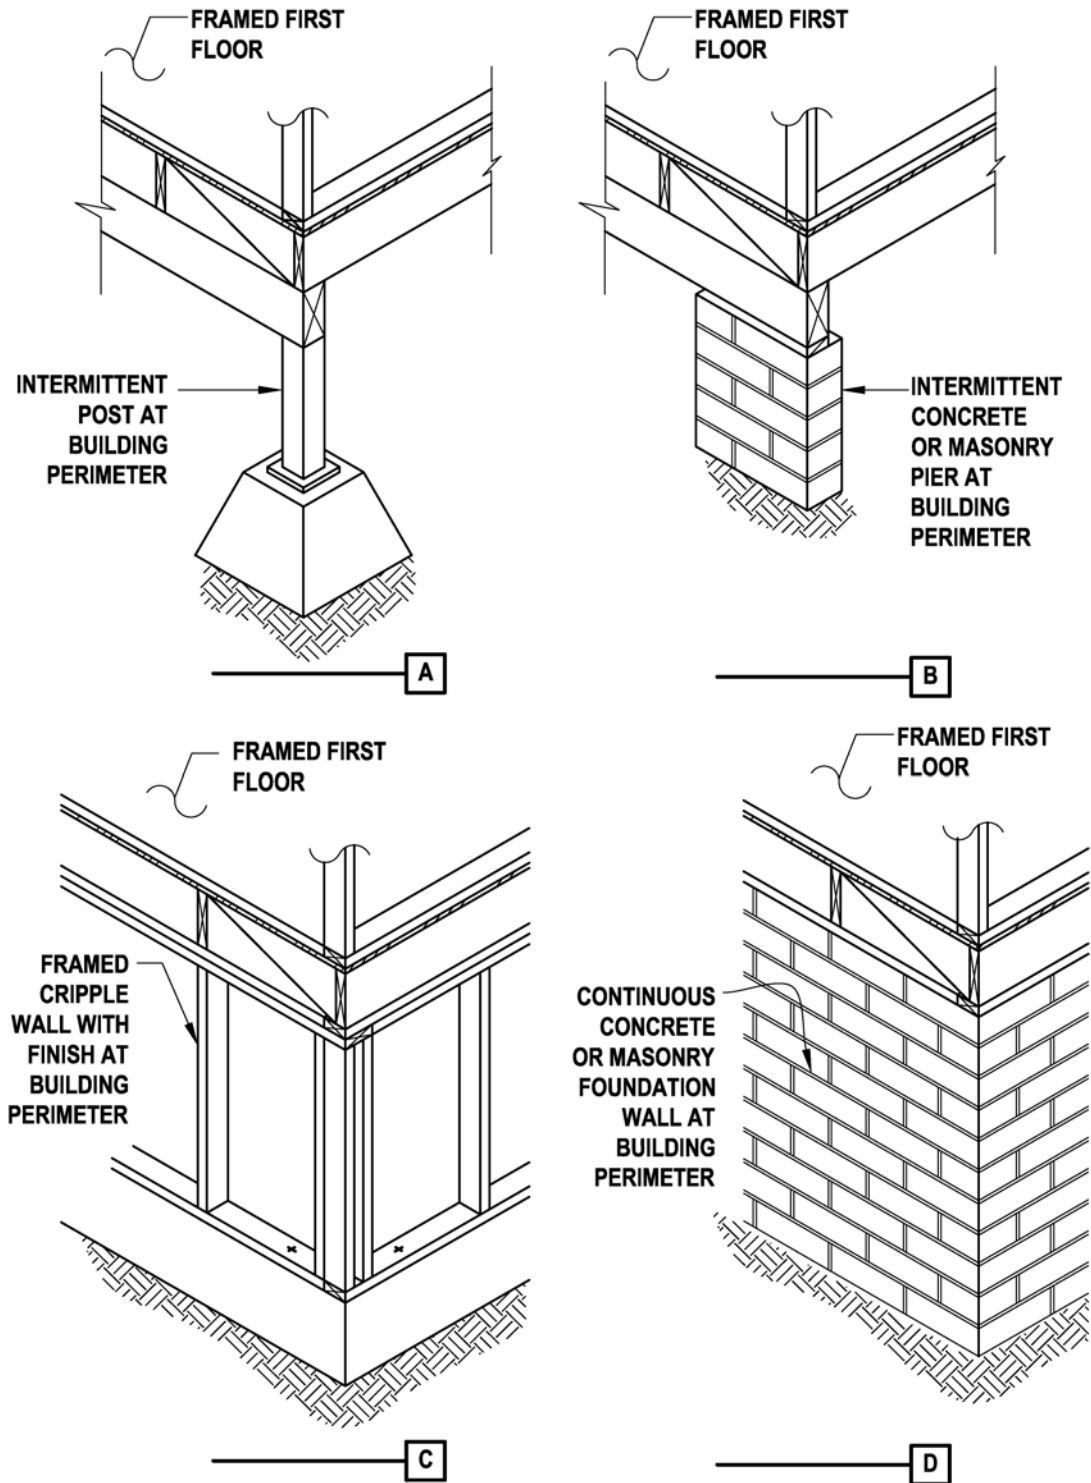
Figure 5.1-2: Systems Between First Framed Floor and Grade – Level Lot Sites

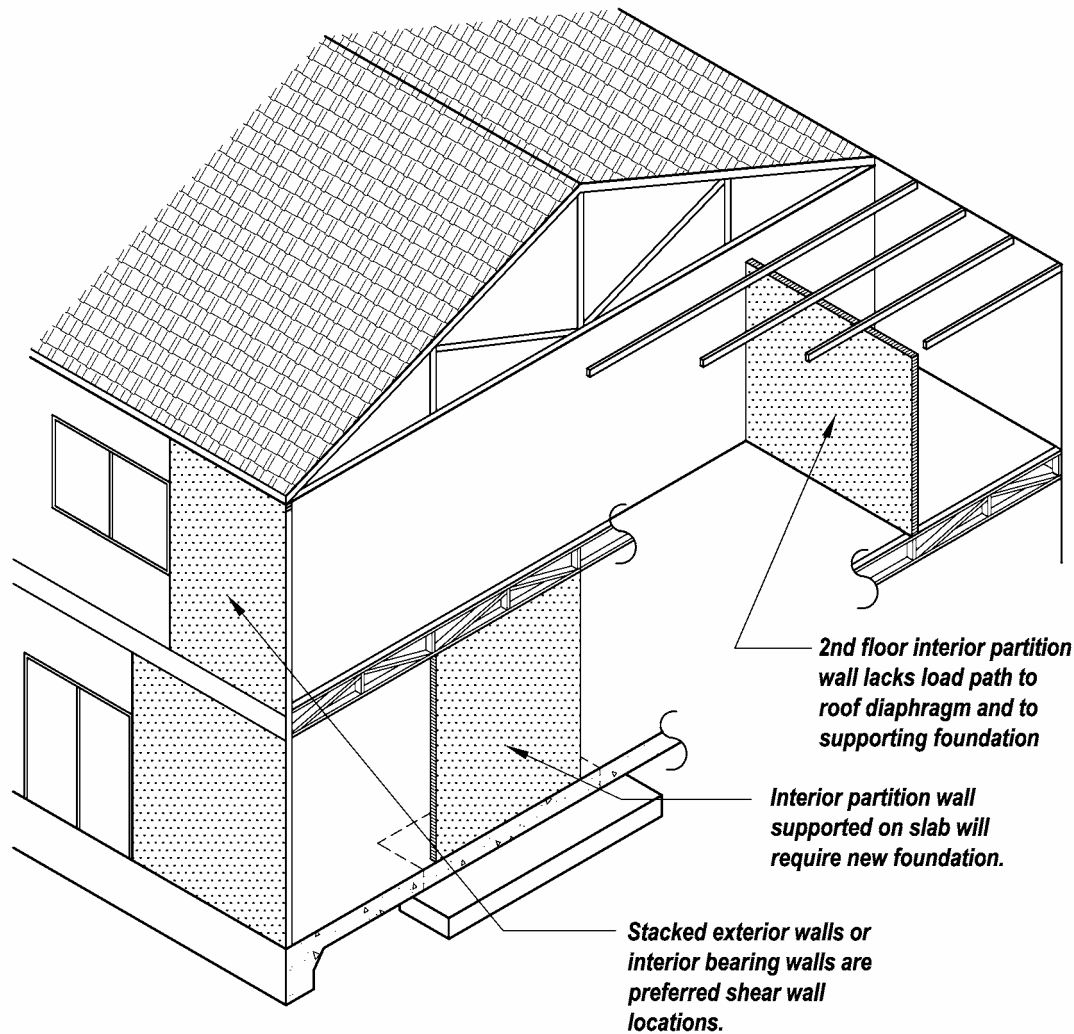
Figure 5.4.1-2: Preferred and Less Preferred Shear Wall Locations

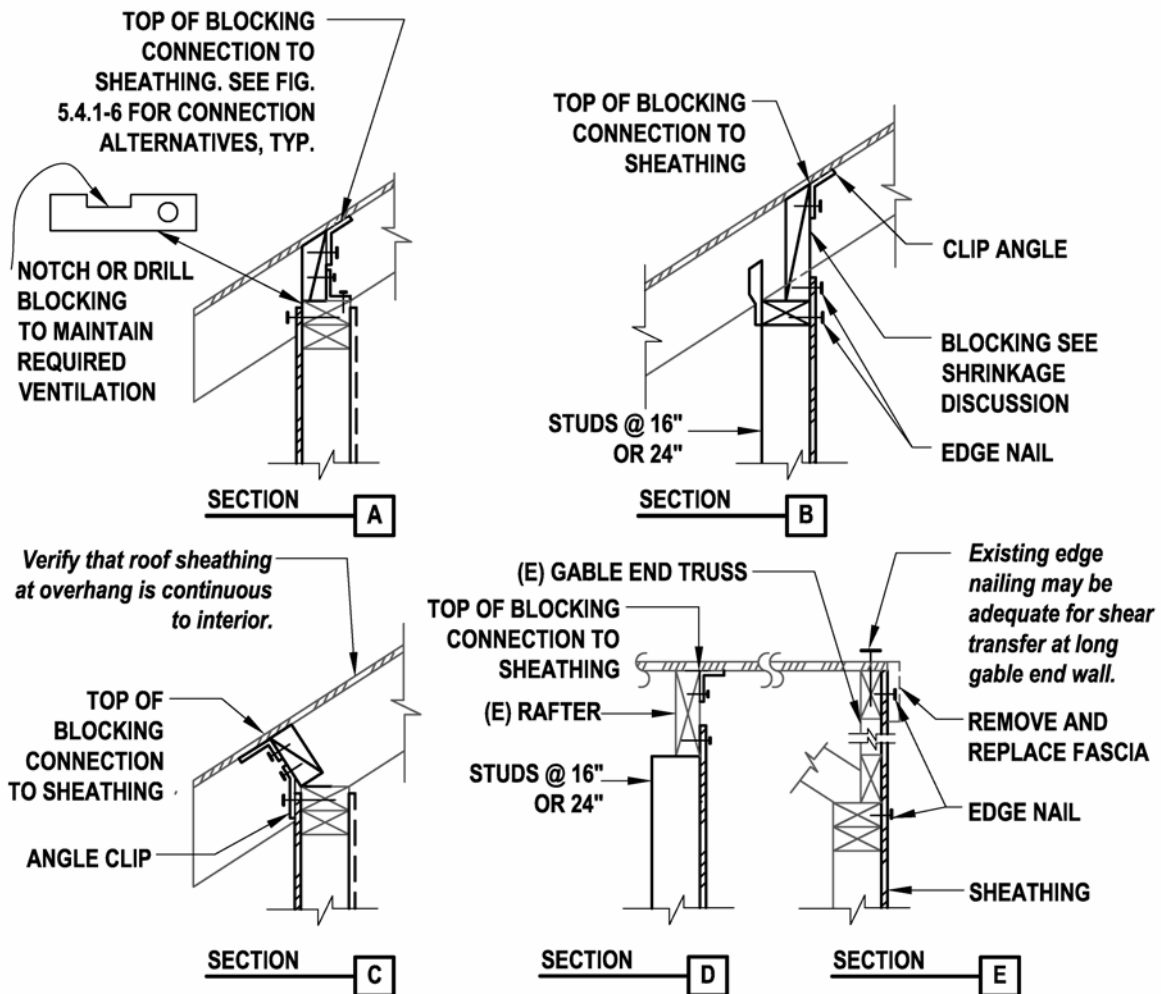
Figure 5.4.1-5: Load Path from Roof Diaphragm to Top of Shear Wall

Figure 5.4.1-5 shows a series of top of shear wall details where the shear is being transferred from a roof diaphragm into the top of the wall. Since most diaphragms in residential construction are not blocked, the unit capacity of the new shear wall is likely to be higher than the unit

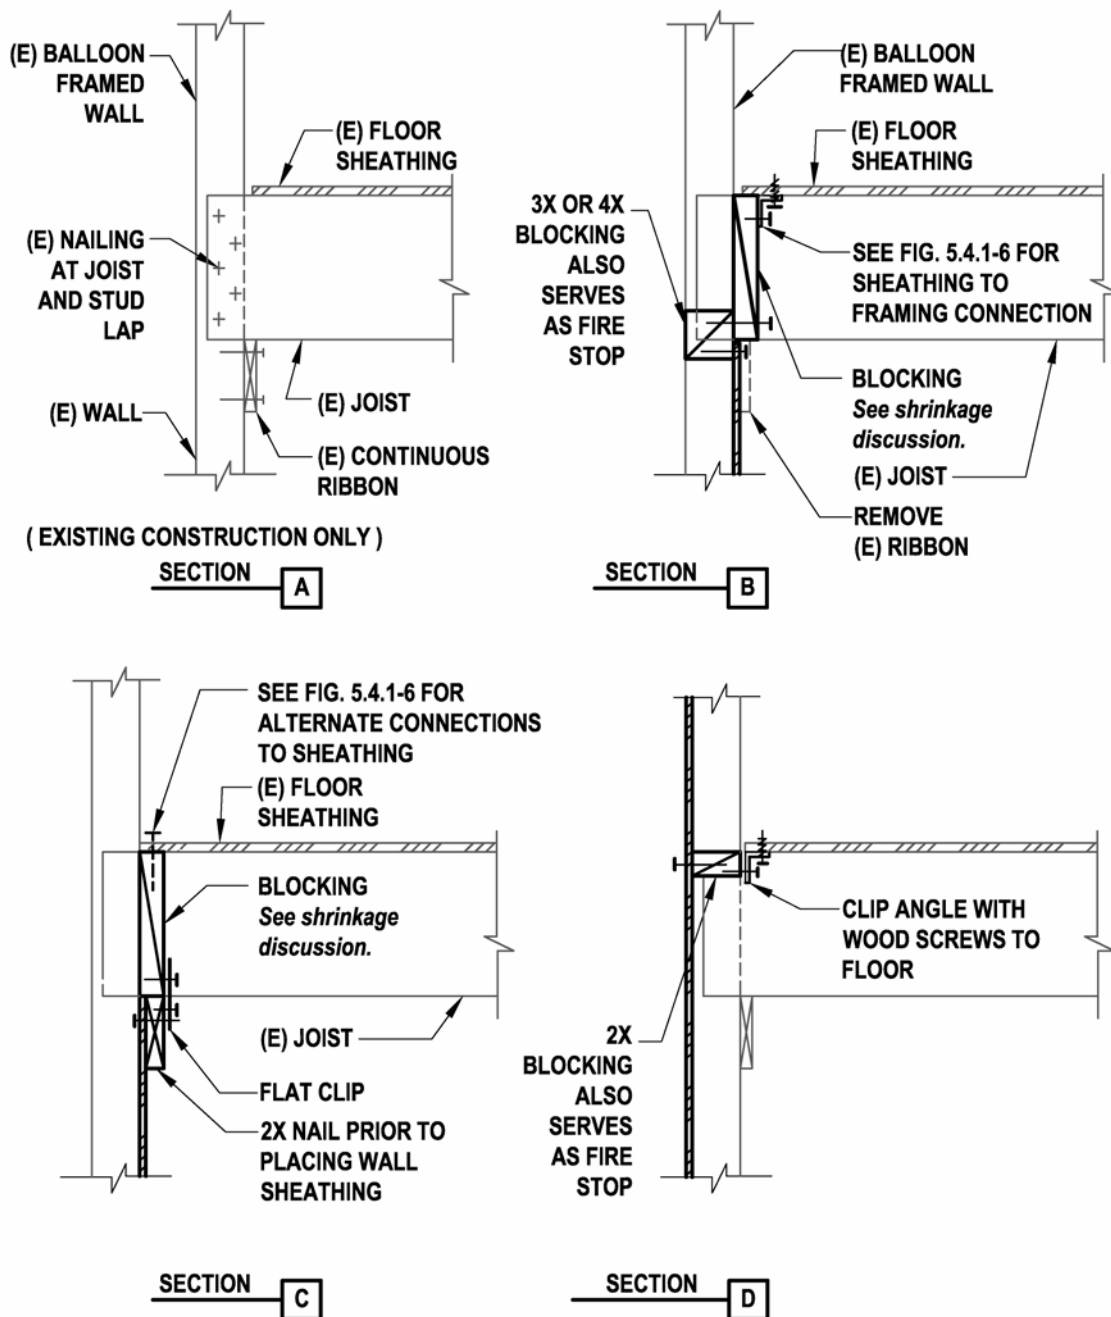
Figure 5.4.1-8: Load Path From Floor Diaphragm to Lower Story Shear Wall – Balloon Framing

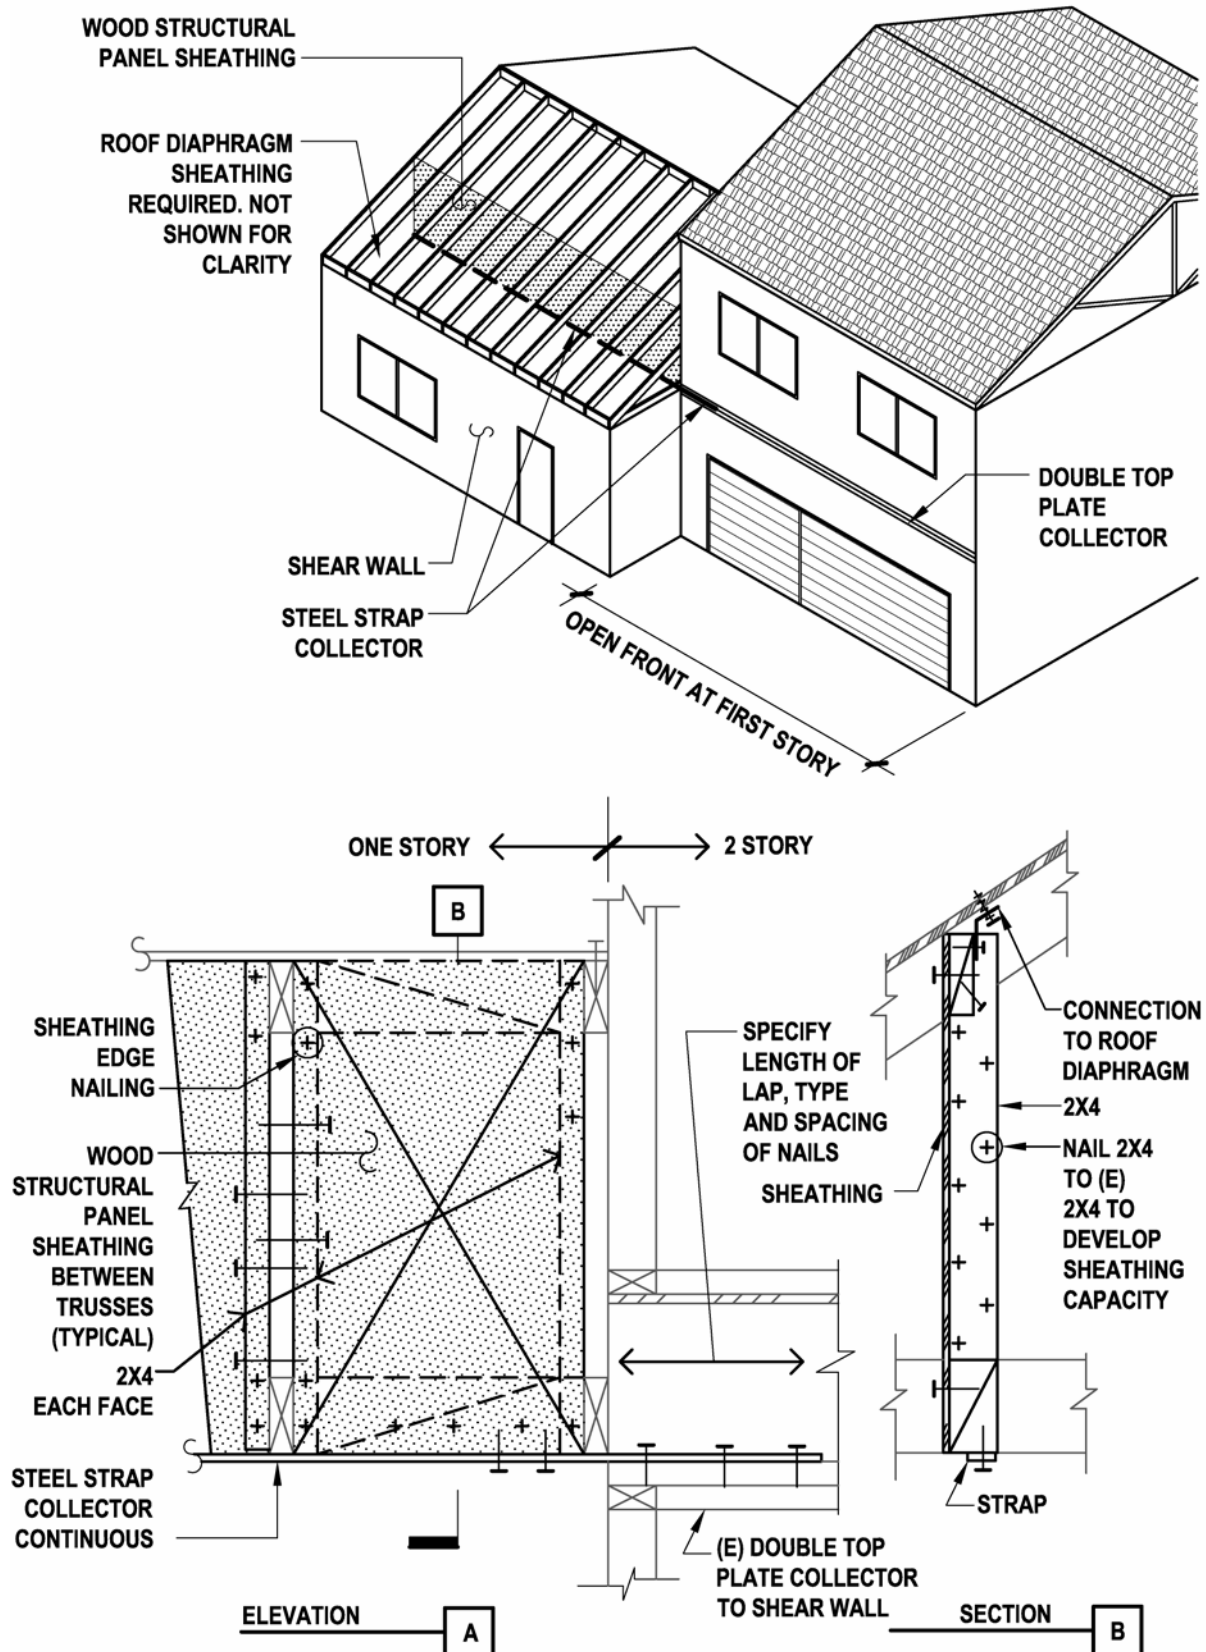
Figure 5.4.2-1: Collector from Garage Open Front to Adjacent Dwelling

Figure 5.4.2-1 shows one of several possible methods of providing a collector. In the illustrated approach, a steel strap ties the top plates from the garage open-front to wood structural panel sheathed infill panels between the roof trusses in the one-story portion of the building. The infill panels transfer the load from the truss bottom chord up to the roof diaphragm, where loads can be carried to the shear walls. In Figure 5.4.2-1, a vertical eccentricity exists between the collector

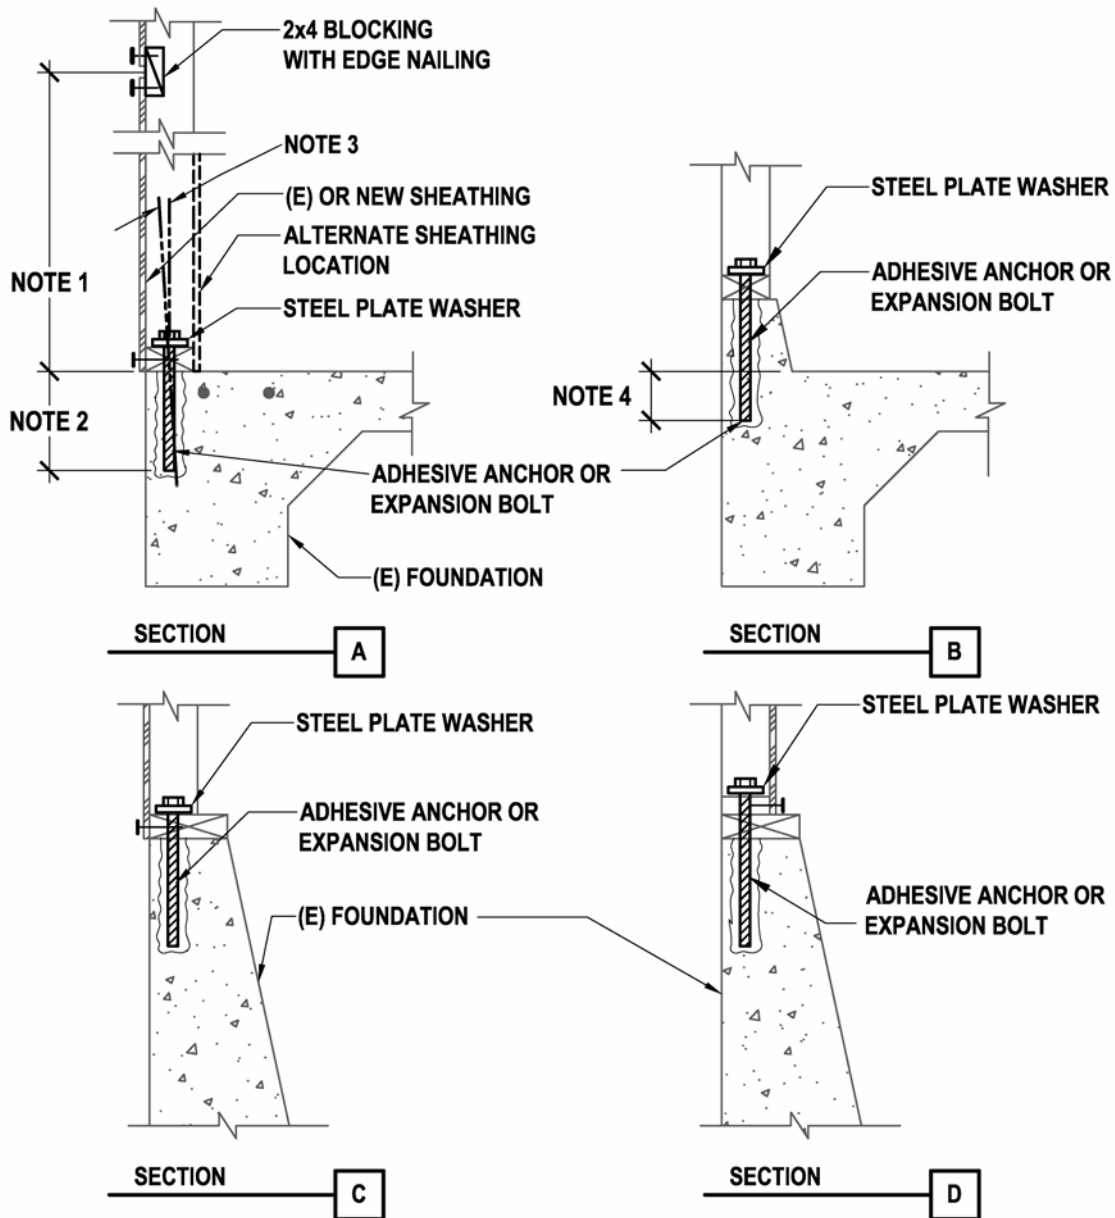
Figure 5.4.3-2: Added Anchor Bolt at Existing Partially Grouted Concrete Masonry Foundation

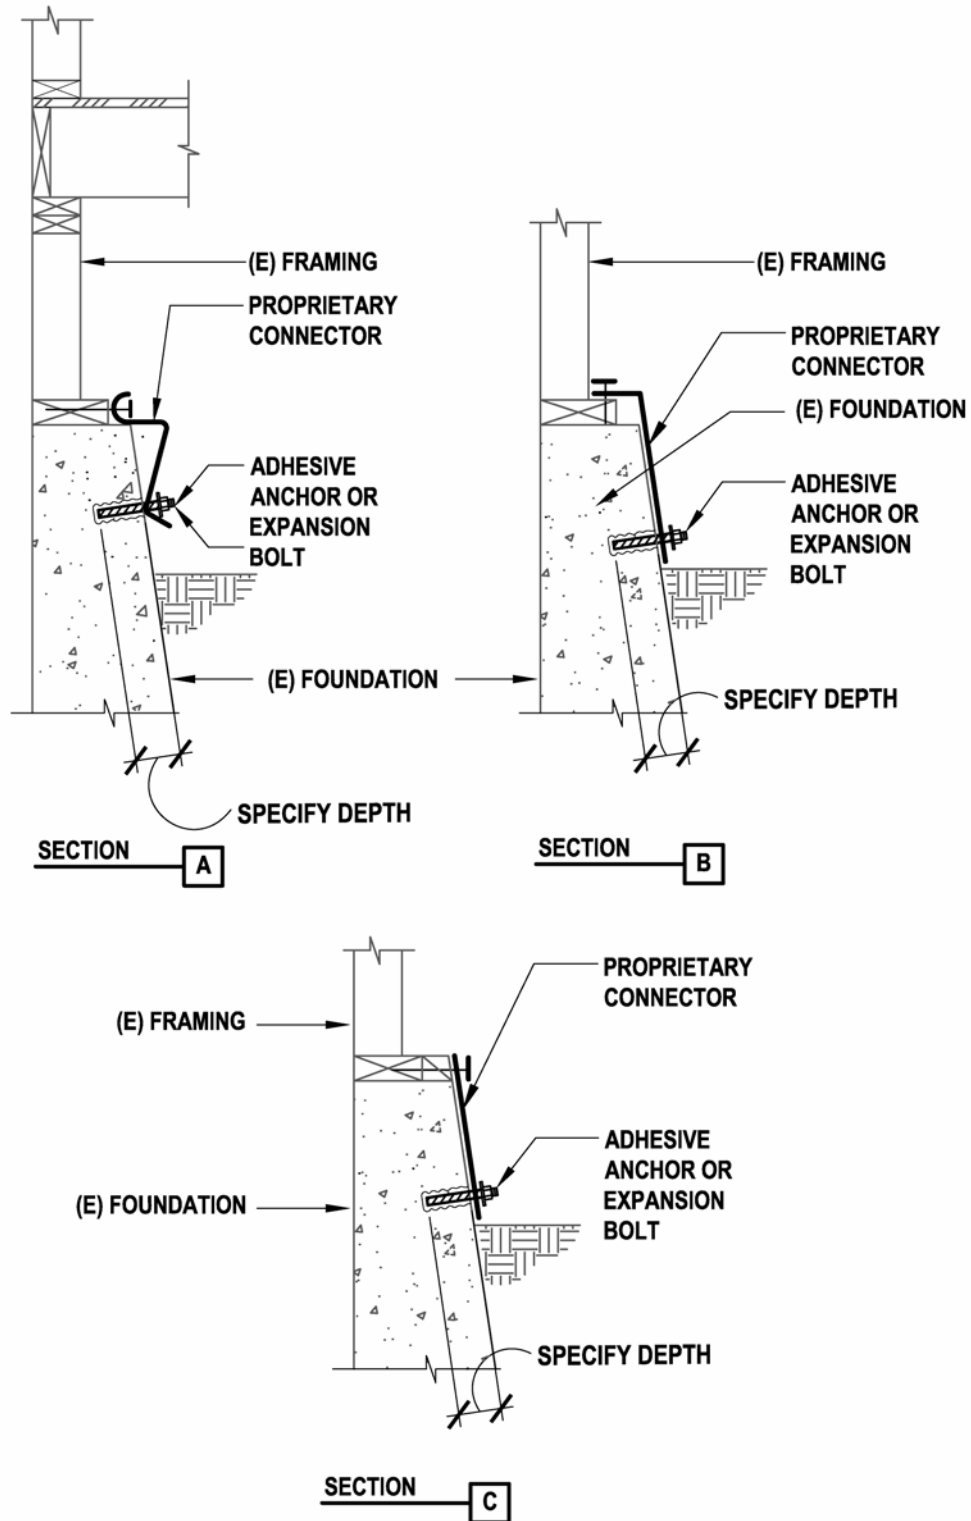
Figure 5.4.3-3: Anchorage to Existing Foundation Using Proprietary Connectors

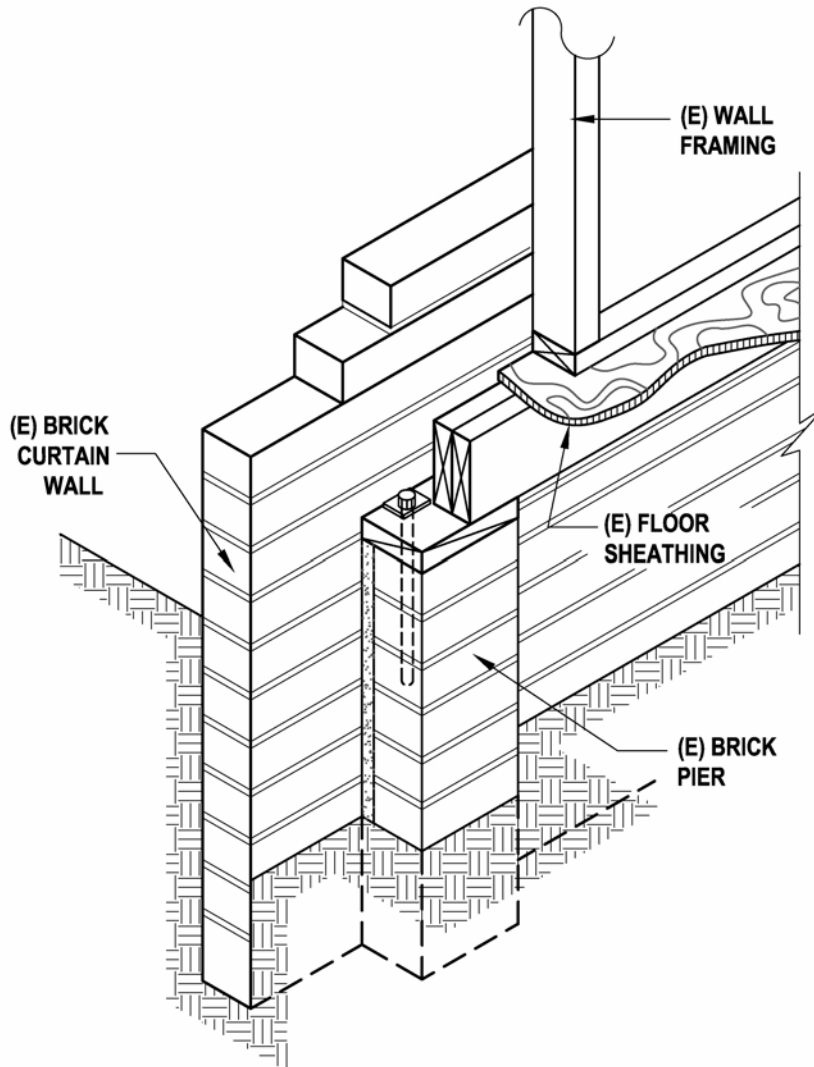
Figure 5.4.3-4: Pier and Curtain Wall Foundation System with Inadequate Load Path Between Shear Walls and Foundation

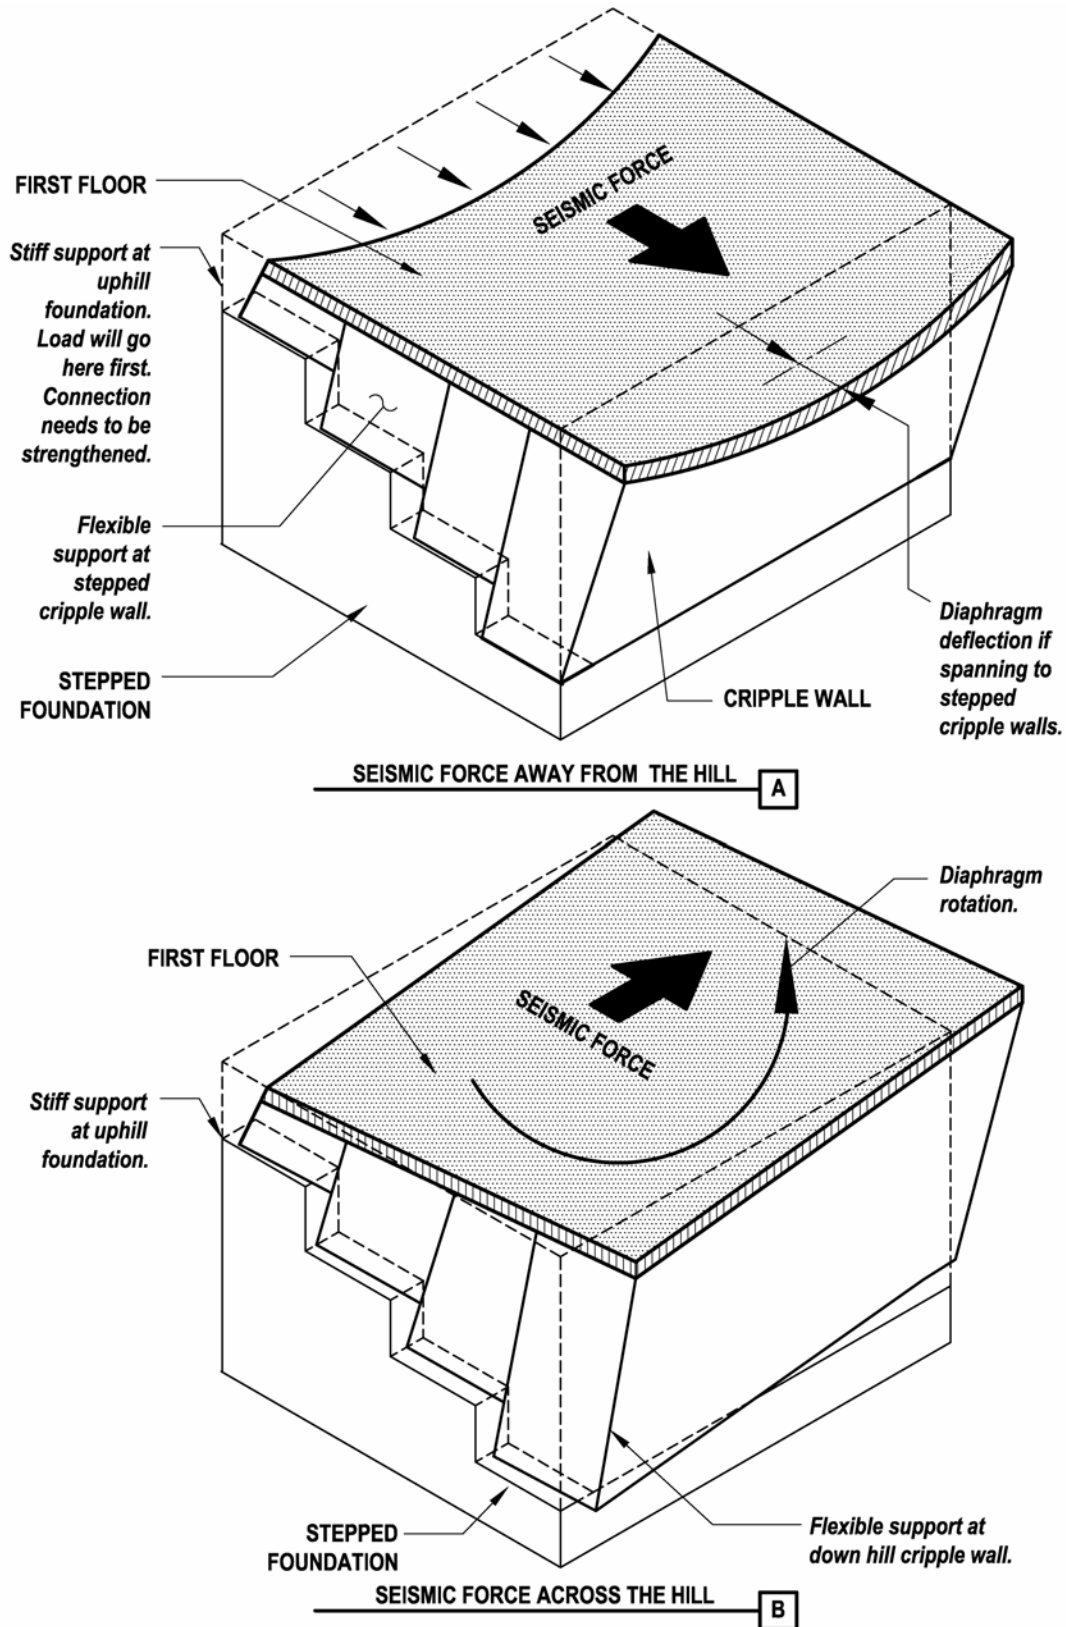
Figure 5.4.5-1: Hillside Home Response to Seismic Forces
Adapted from Von Winterfeldt, Roselund and Kitsuse (2000)

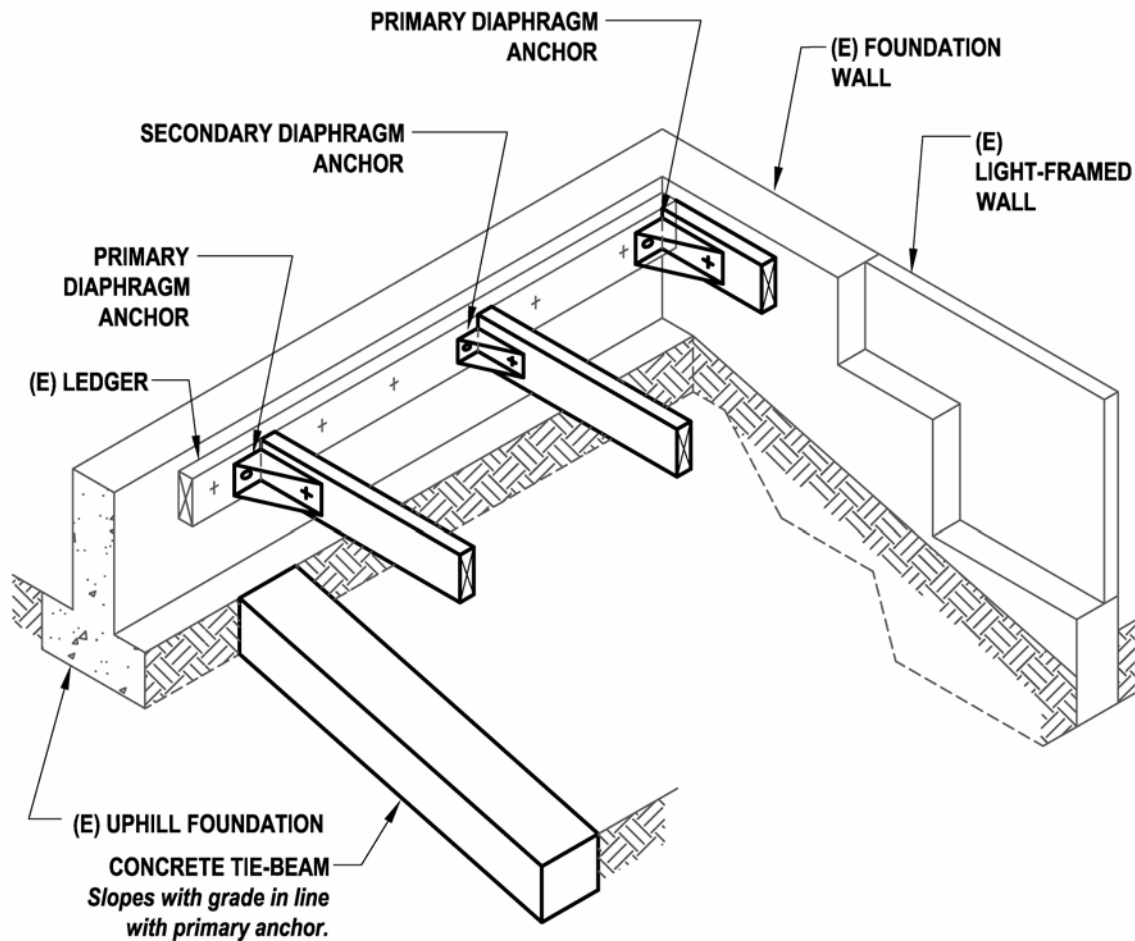
Note. Diaphragm anchor prevents existing ledger from pulling off at uphill foundation.

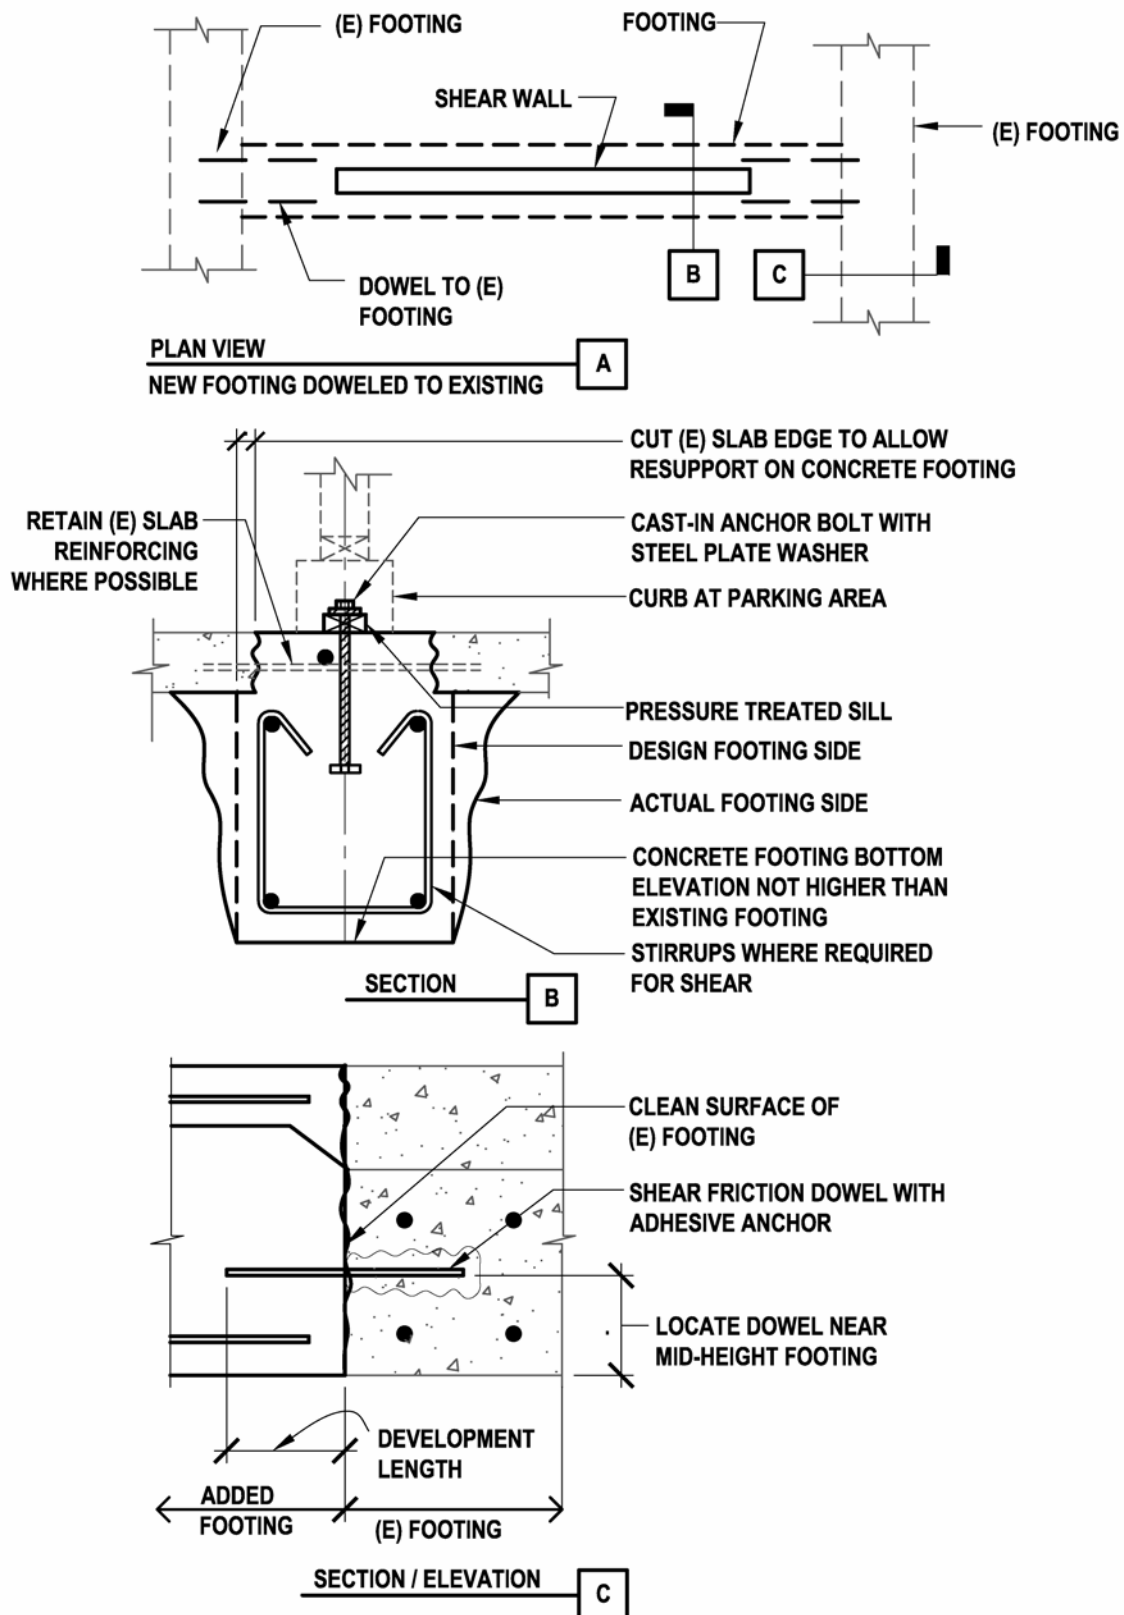
Figure 6.4.2-2: Added Shear Wall Supported by New and Existing Footings

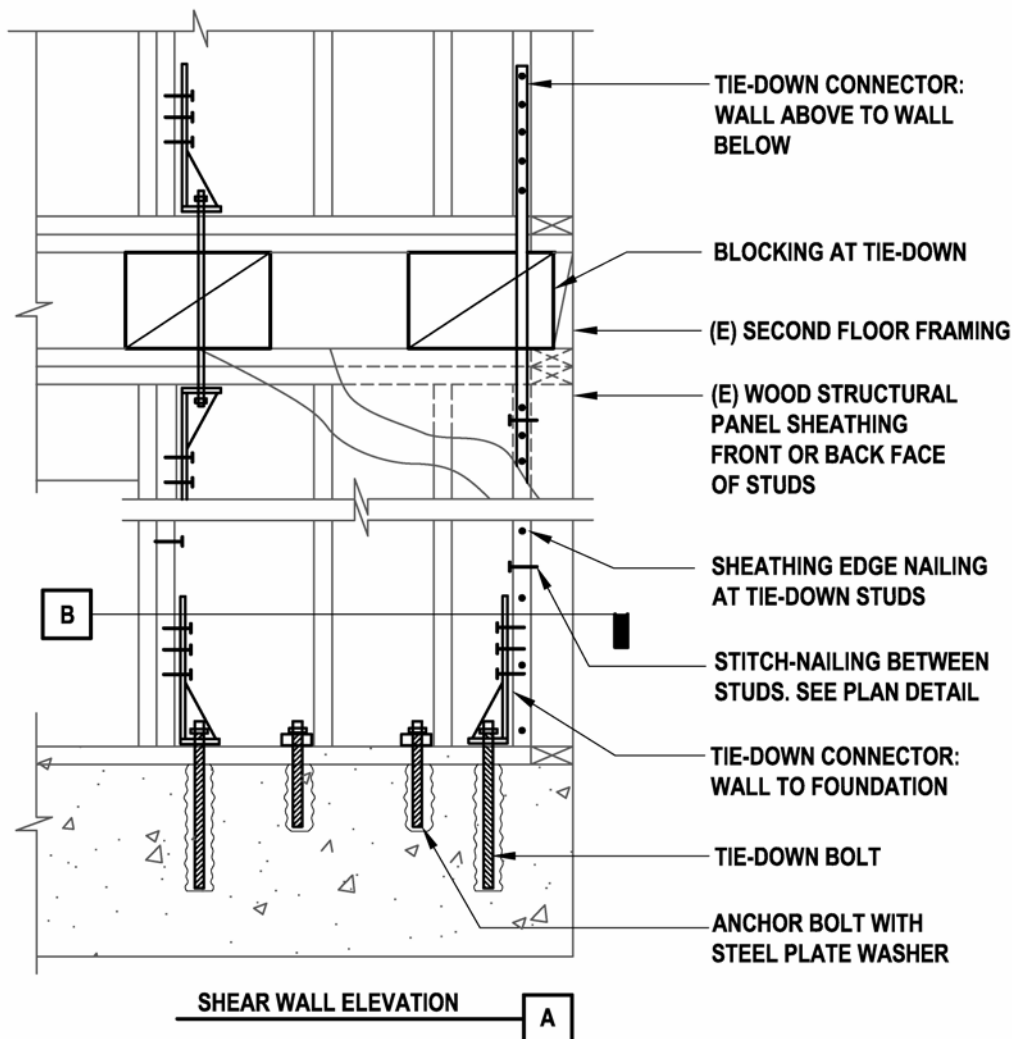
Figure 6.4.4-1A: Shear Wall Elevation with Enhanced Overturning Detailing

Figure 6.4.4-1A illustrates a shear wall elevation with commonly used tie-down connectors for a slab-on-grade condition. Figure 6.4.4-1B illustrates fastening to develop a load path between the tie-down connector and the shear wall sheathing edge nailing. For sheathing and framing conditions other than those shown, similar fastening must be provided to complete the load path.

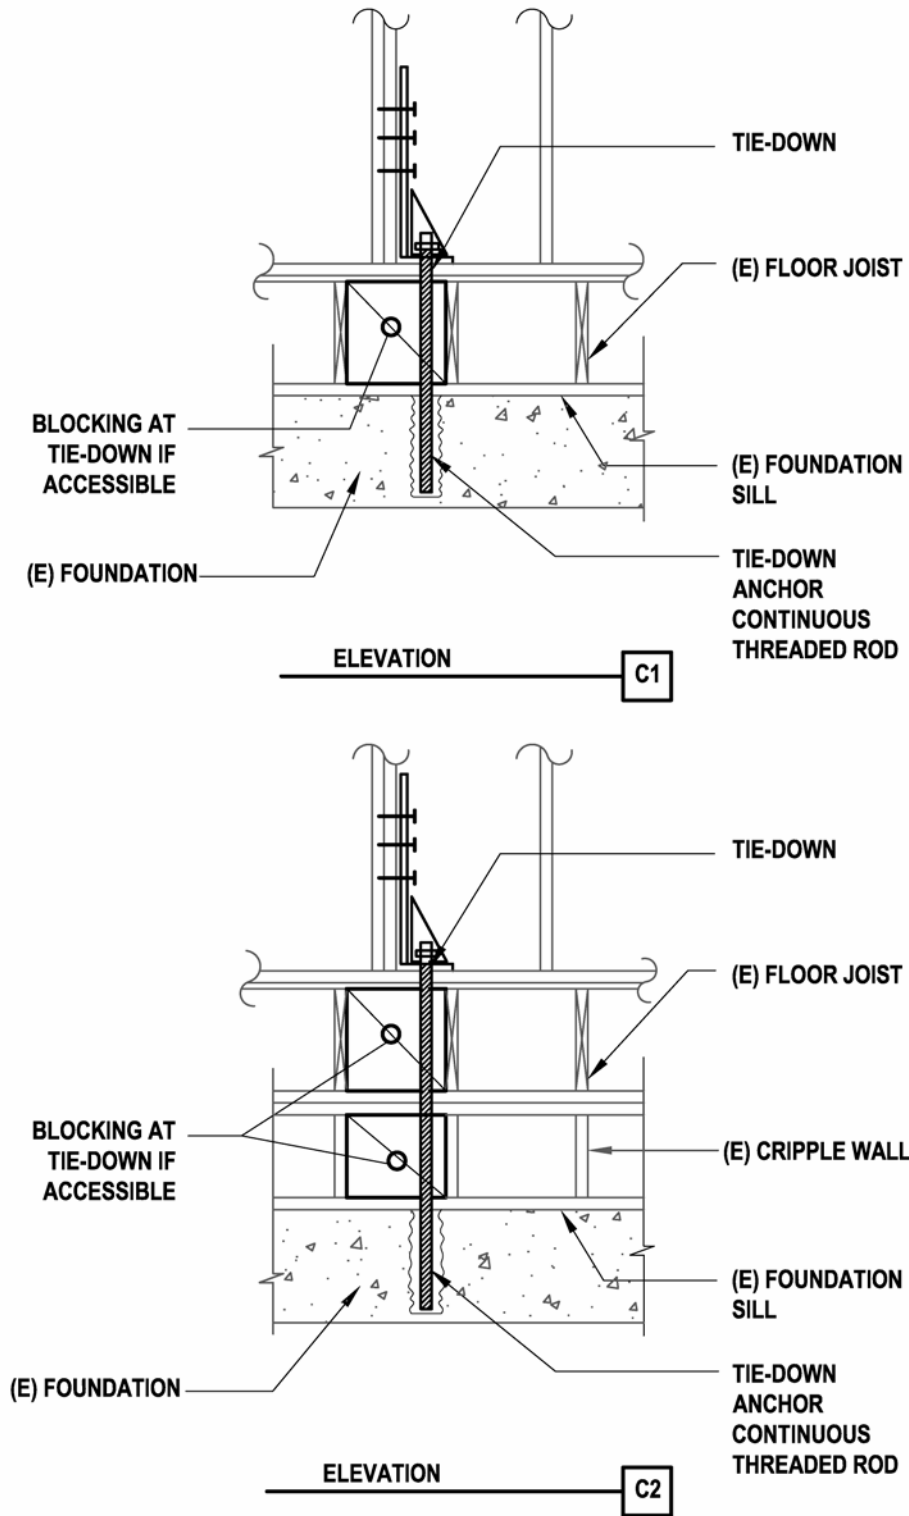
Figure 6.4.4-1C: Tie-down Details at Alternate Base Conditions

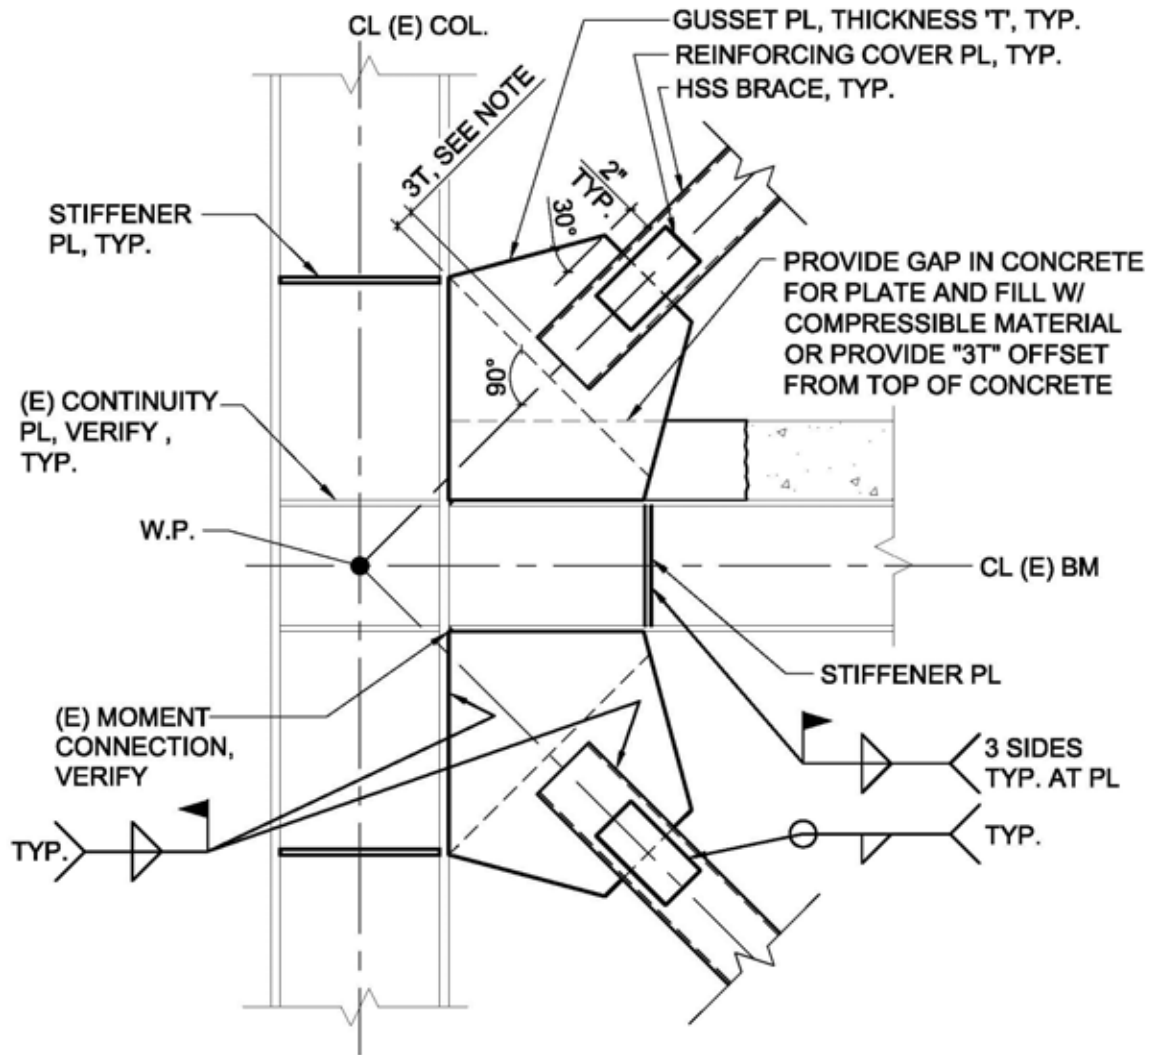
Note:
 AISC recommends $2T$ to allow for restraint-free plastic rotations.
 $3T$ is shown here to accommodate overcutting of HSS slots.

Figure 8.4.1-1: HSS Brace at Existing Beam-Column Connection in SCBF

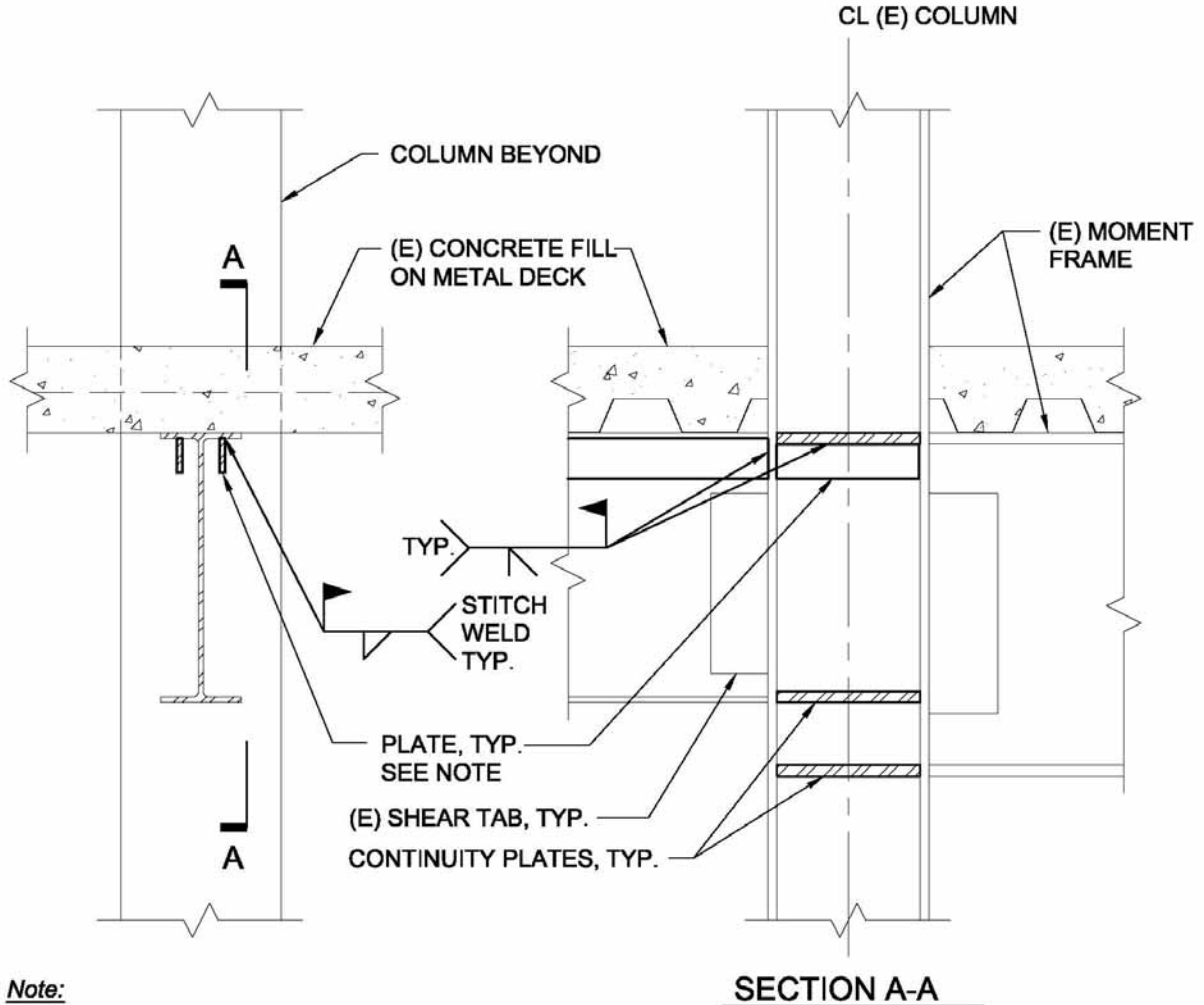
Figure 8.4.4-1: Plate Collectors at Existing Beam

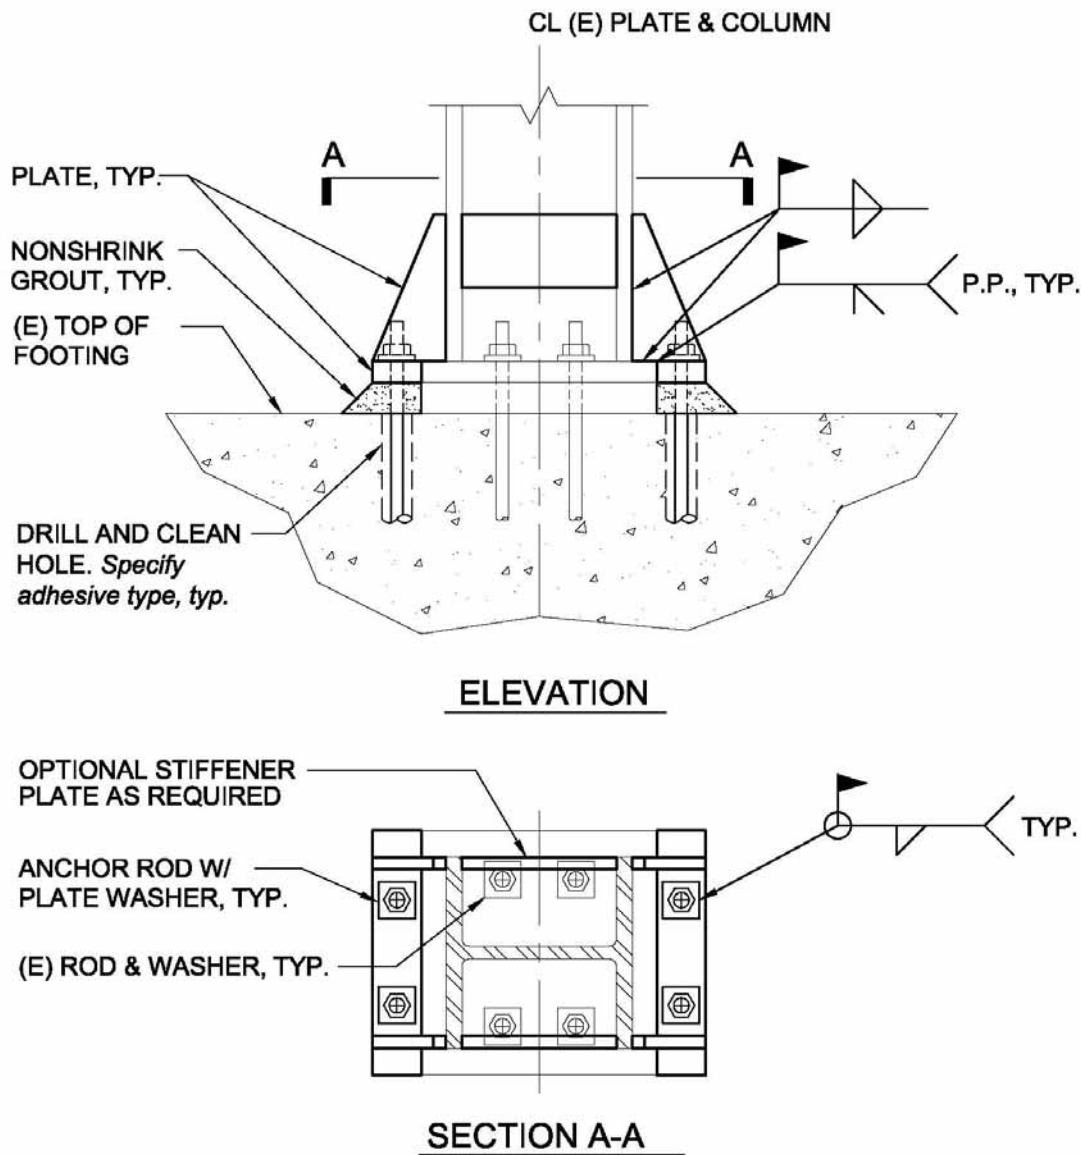
Figure 8.4.5-1: Modified Base Plate to Increase Uplift Capacity
