Techniques for the Seismic Rehabilitation of Existing Buildings

FEMA 547/2006 Edition

Rutherford & Chekene (R & C) Consulting Engineers (Subconsultant) under contract with National Institute of Standards and Technology (NIST).

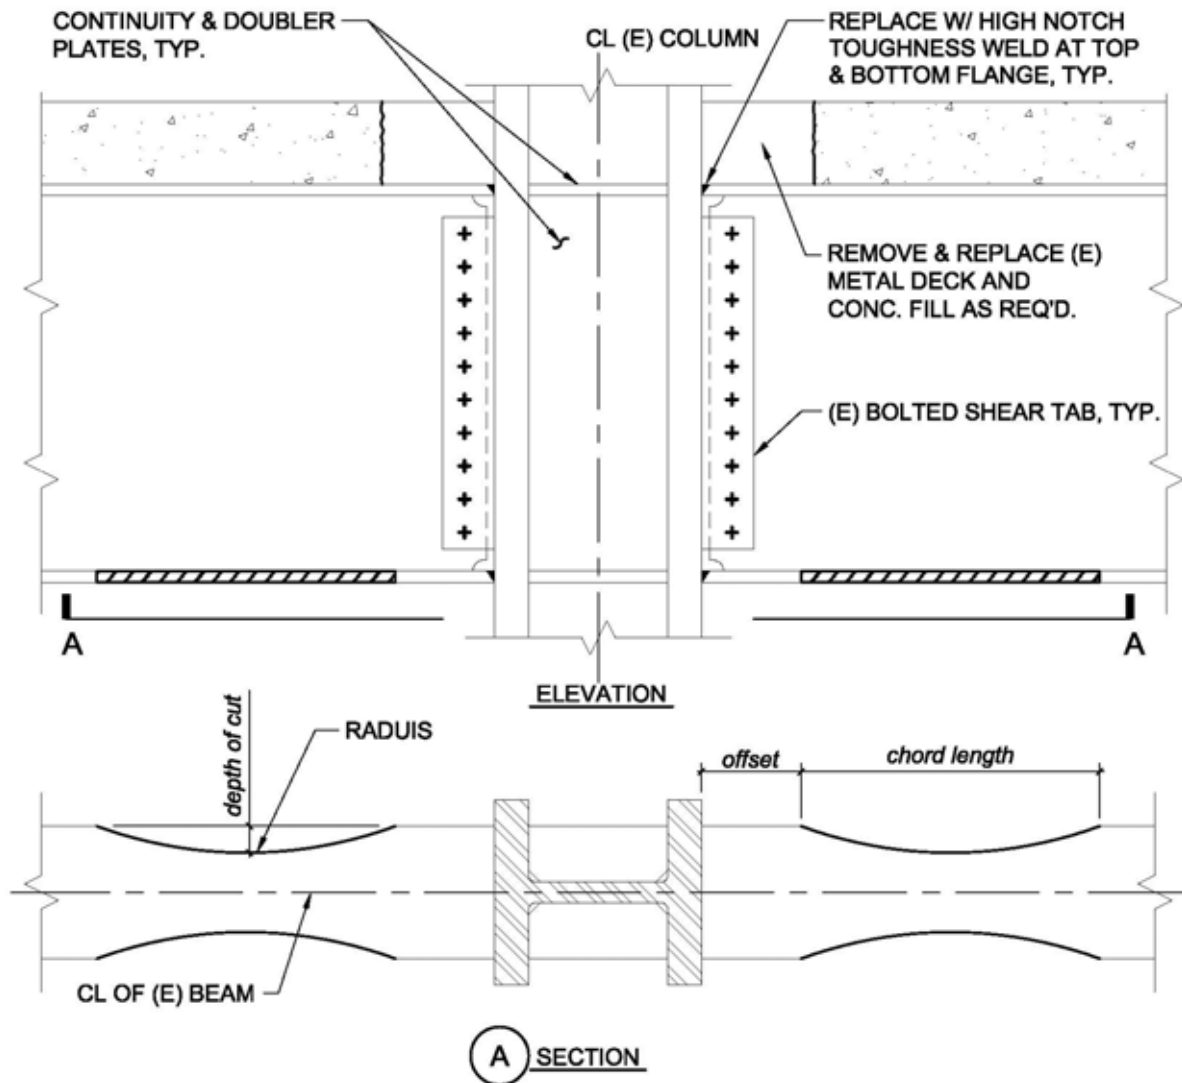
Figure 8.4.6-1: Reduced Beam Section at Bottom Flange of Existing Beam
(adapted from *AISC Design Guide 12*)

length of the cut should also be long enough to control the inelastic strains along the RBS. The radius of the cut is a function of its depth and the chord length. See *AISC Design Guide 12* for specific recommendations and guidelines for selecting these dimensions.

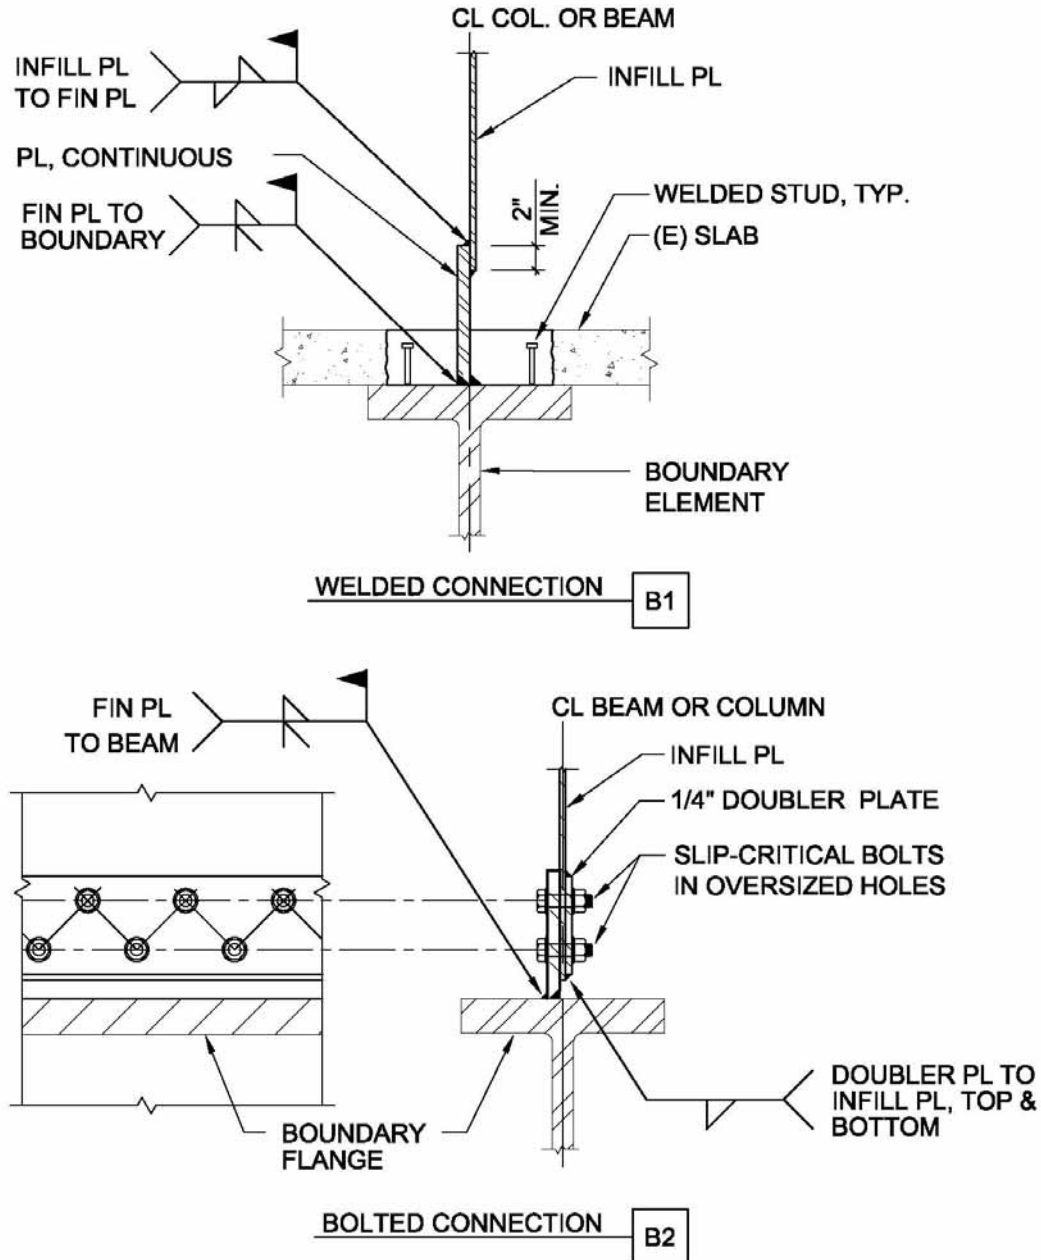
Figure 8.4.8-1B: Fin Plate Connection Options

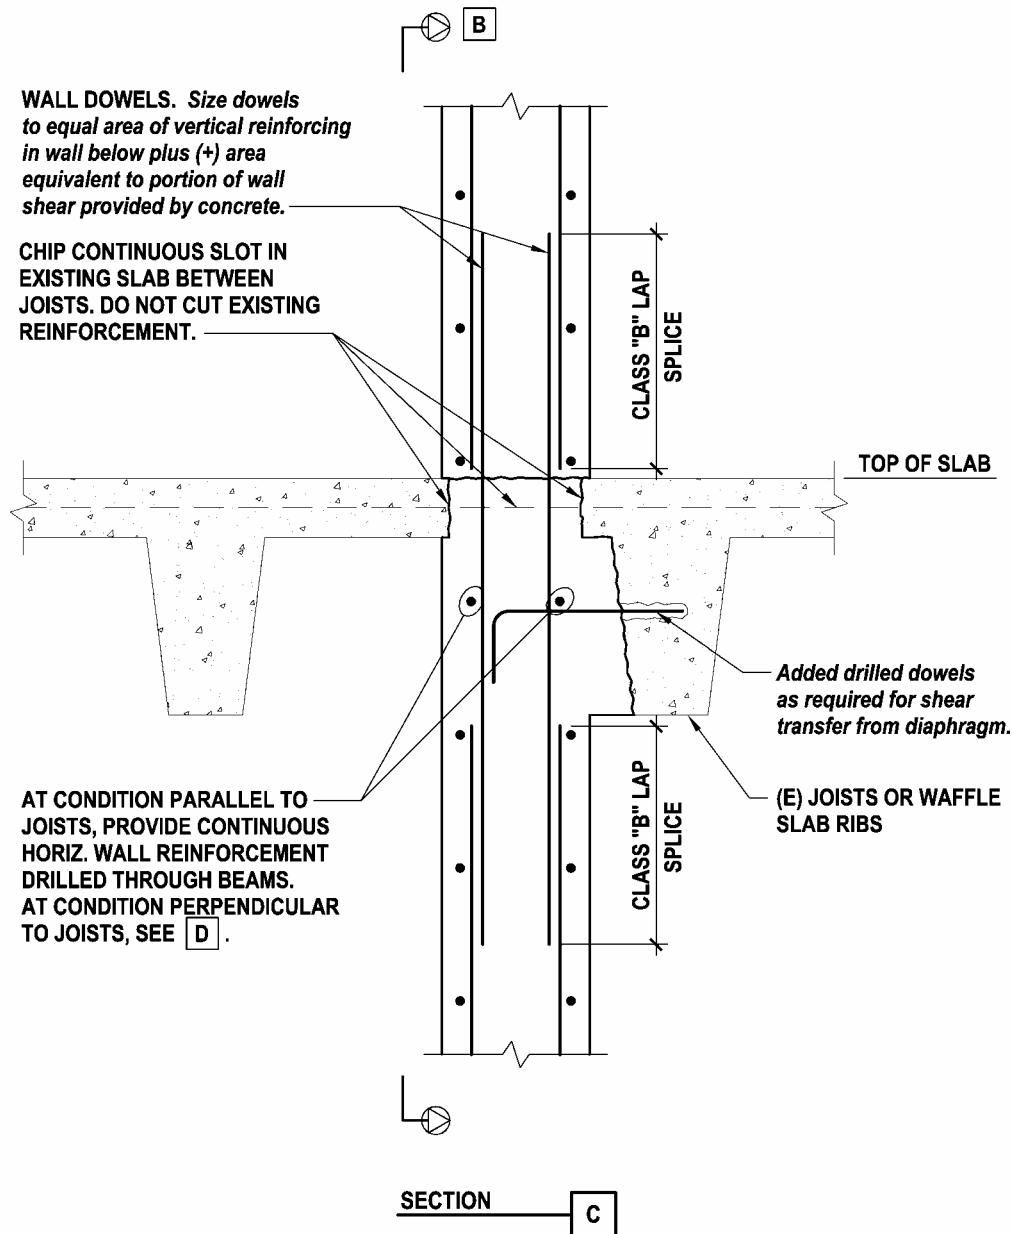
Figure 12.4.2-1C: Connection of Concrete Wall to Concrete Joists or Waffle Slab

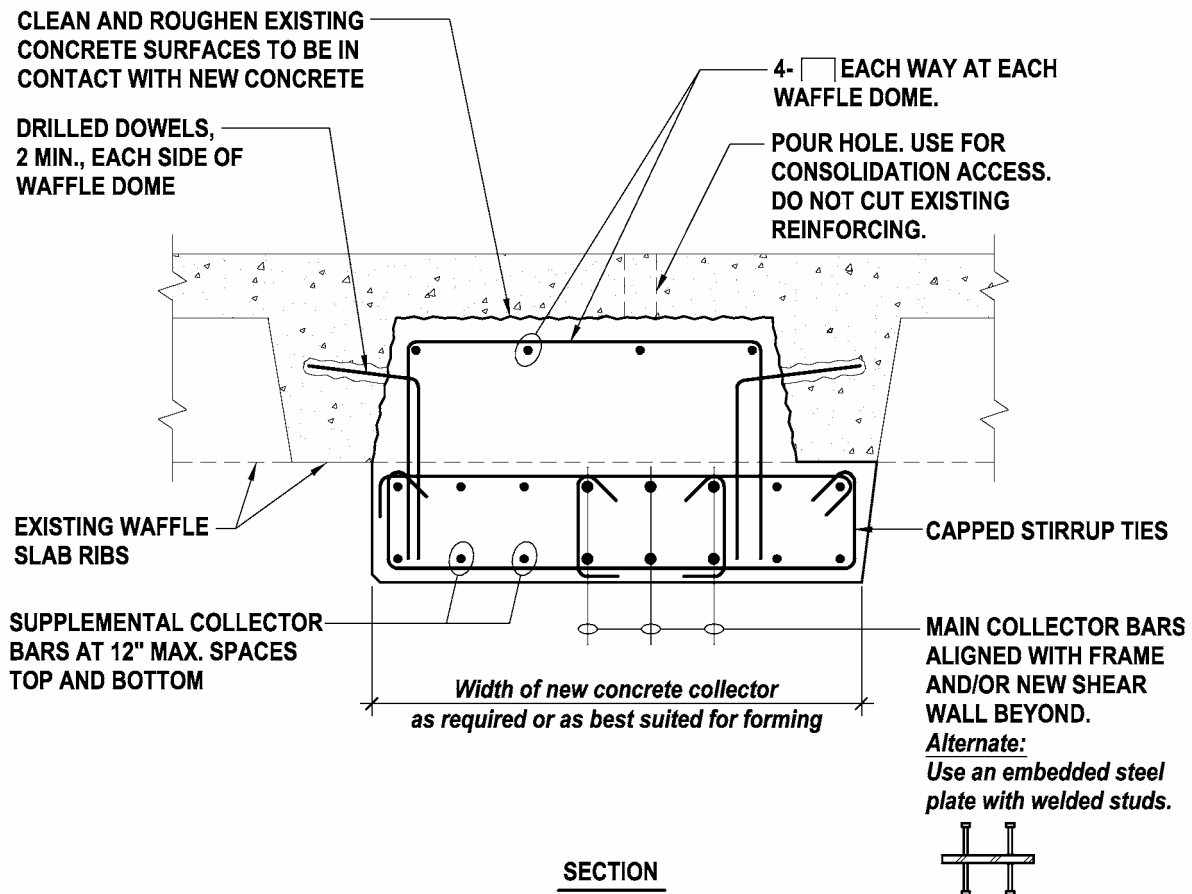
Figure 12.4.3-2: Concrete Collector at Waffle Slab

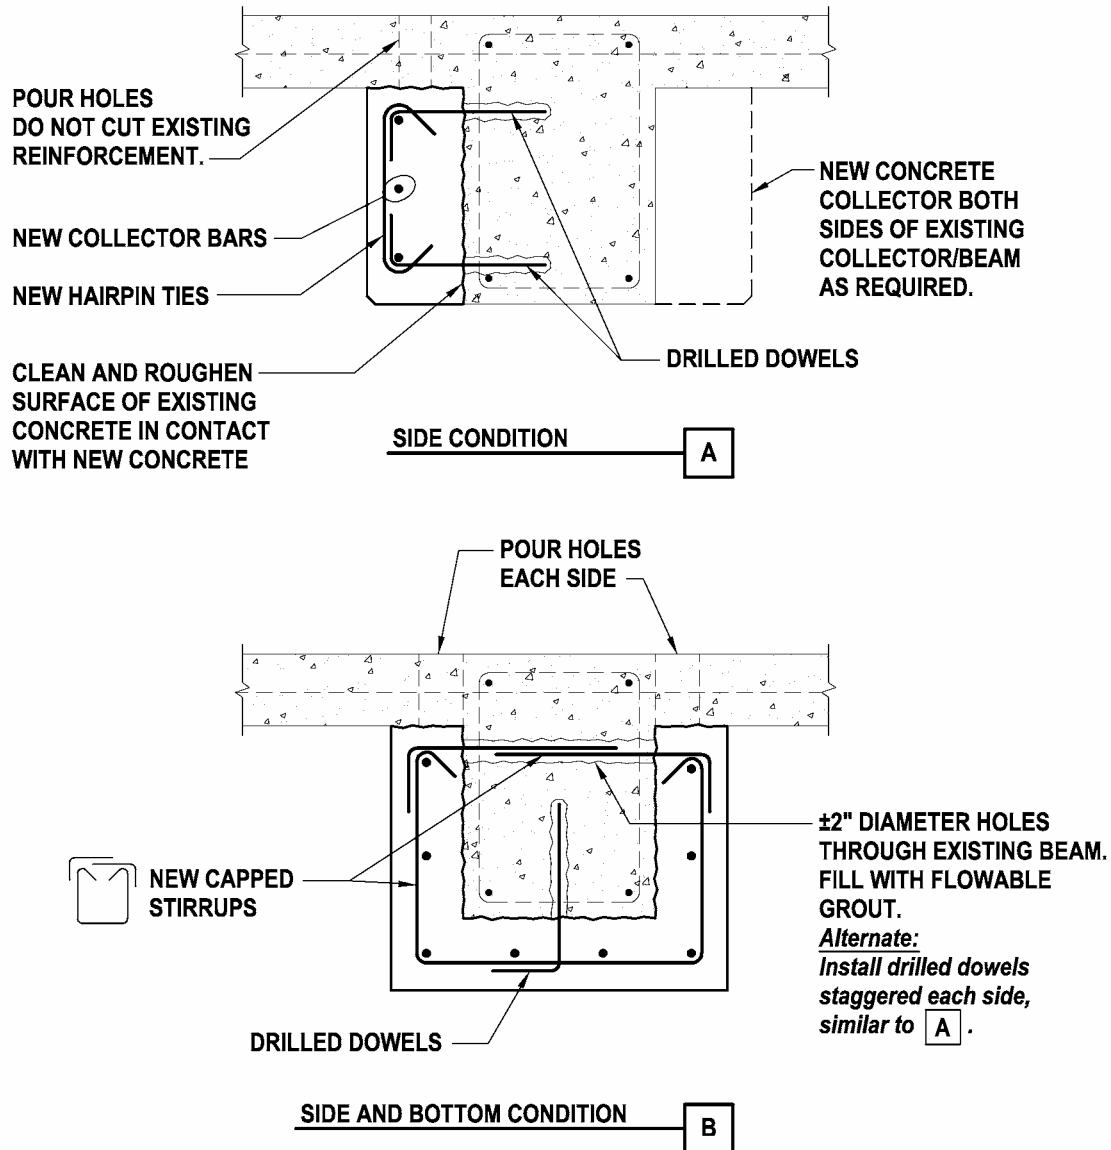
Figure 12.4.3-3: Concrete Collector at Existing Beam

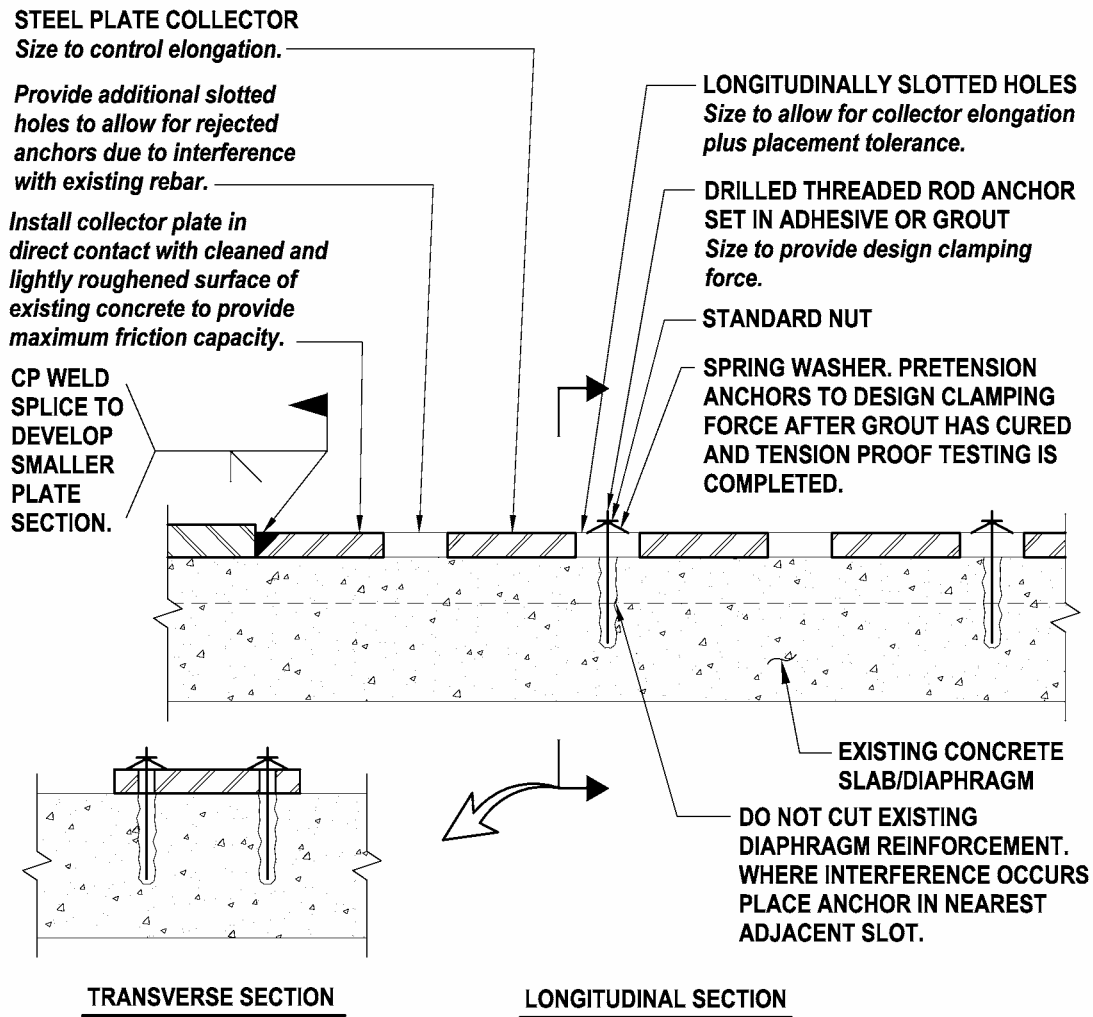
Figure 12.4.3-4: Steel Plate Collector

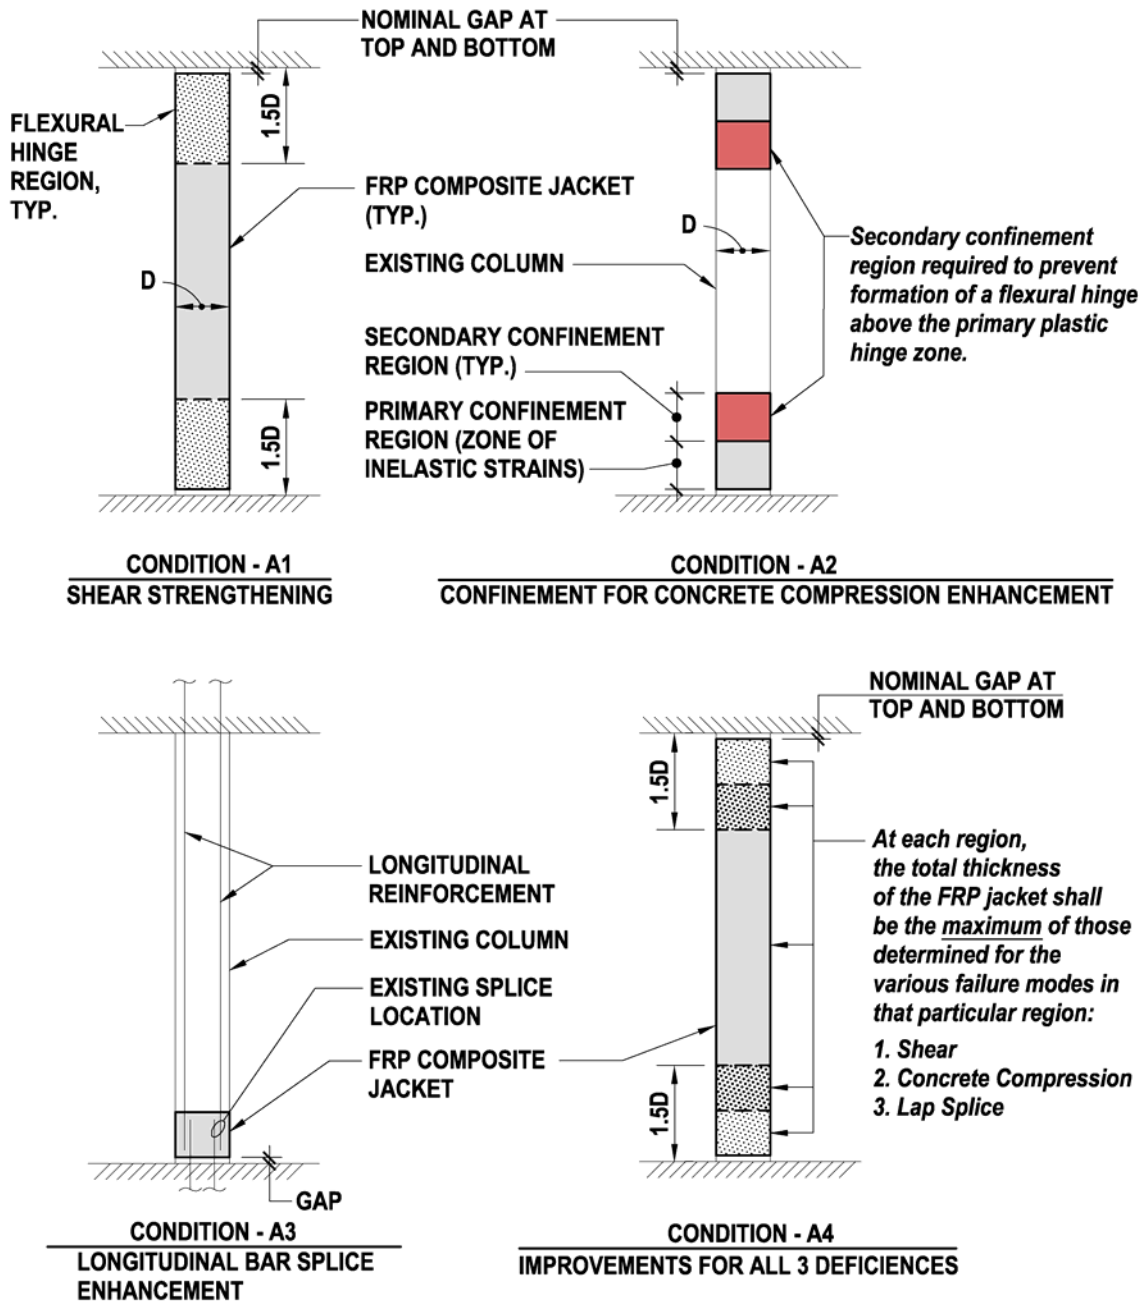
Figure 12.4.4-1A: Seismic Retrofit of Columns Using FRP Composites

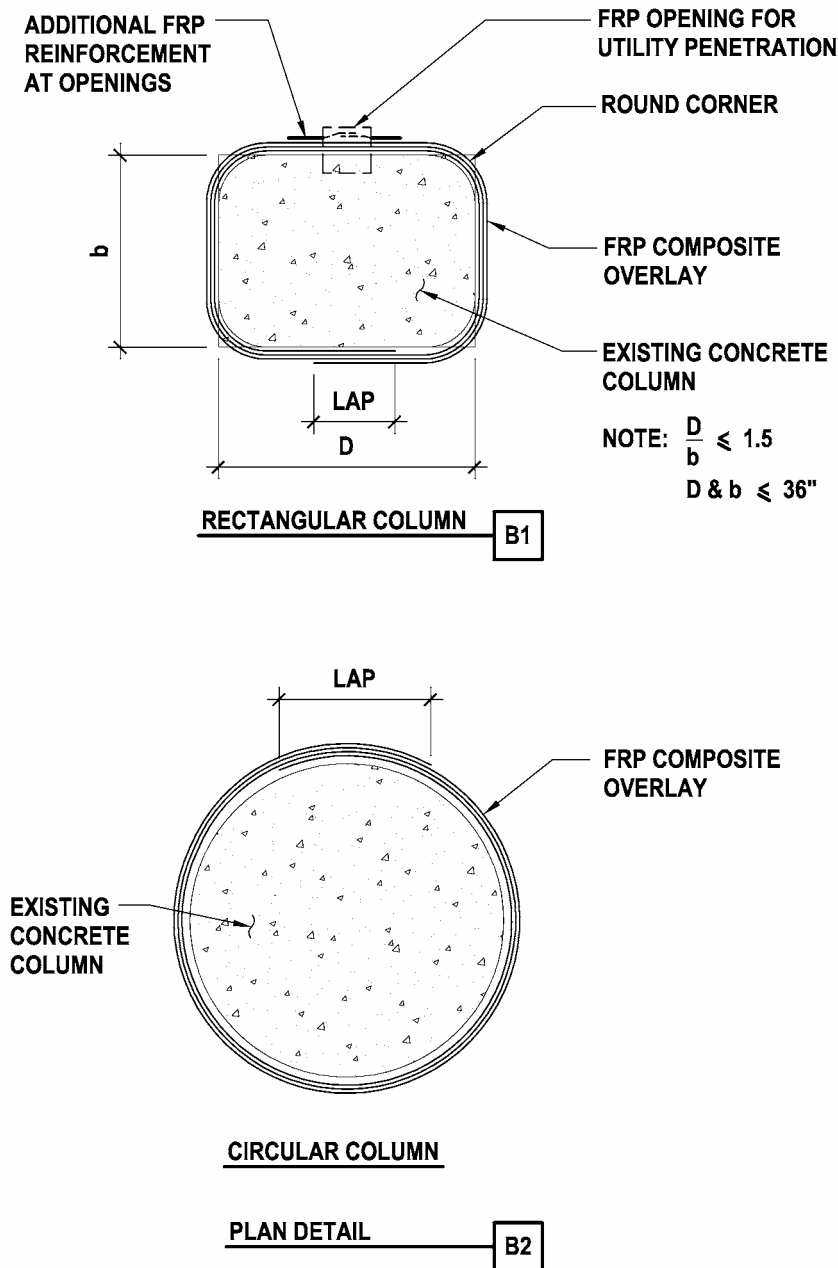
Figure 12.4.4-1B: Seismic Retrofit of Columns Using FRP Composites

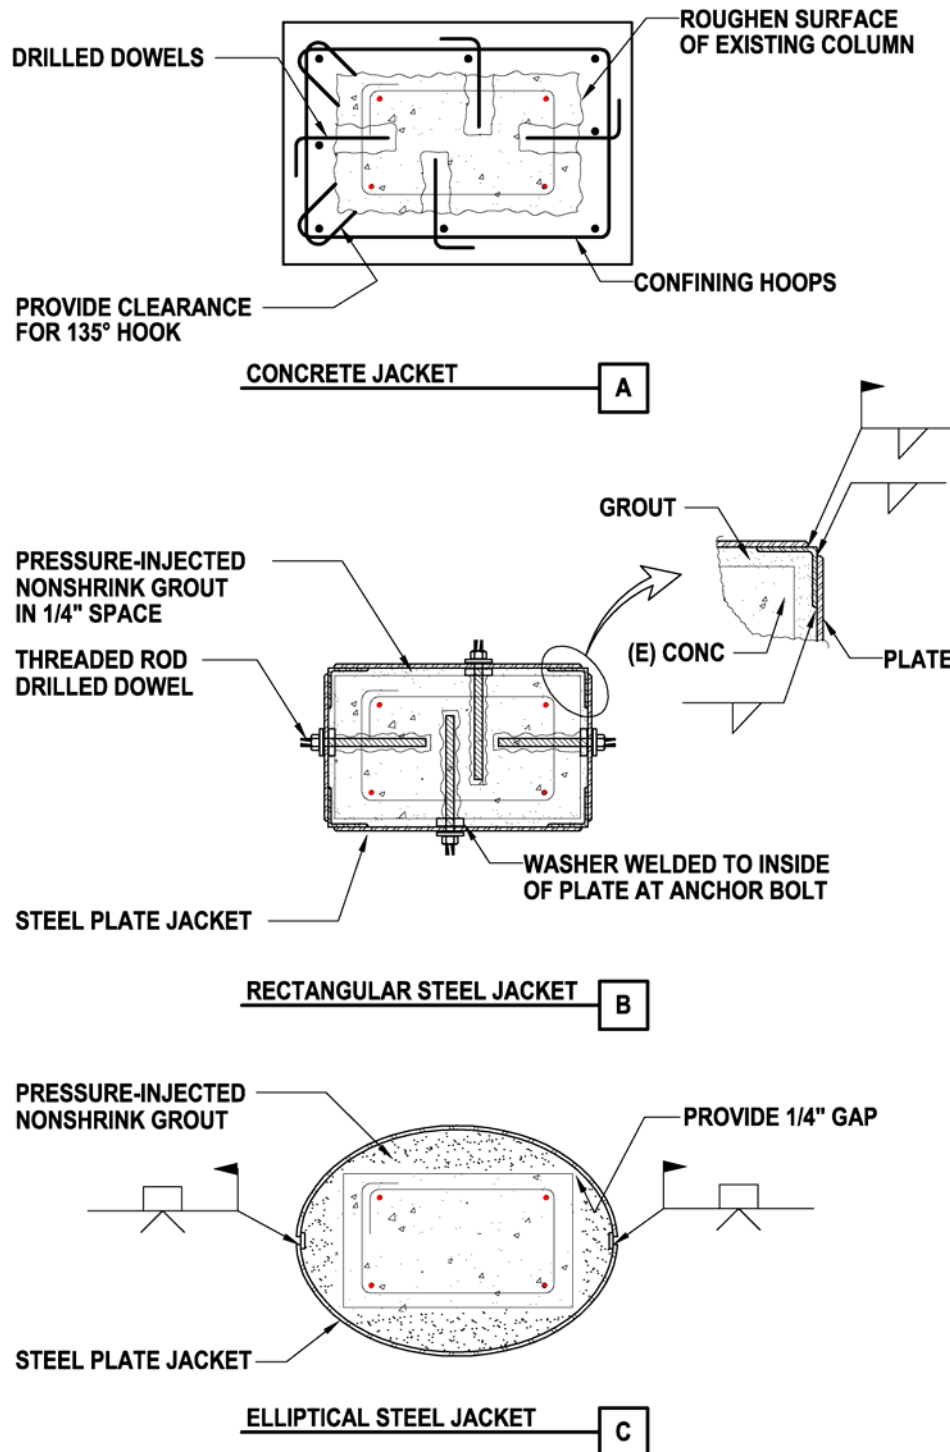
Figure 12.4.5-1: Concrete and Steel Overlays for Concrete Columns

Figure 12.4.5-1 provides examples of concrete and steel jacketing for a rectangular column. Because FRP overlays have become more common, this section will focus on FRP overlays.

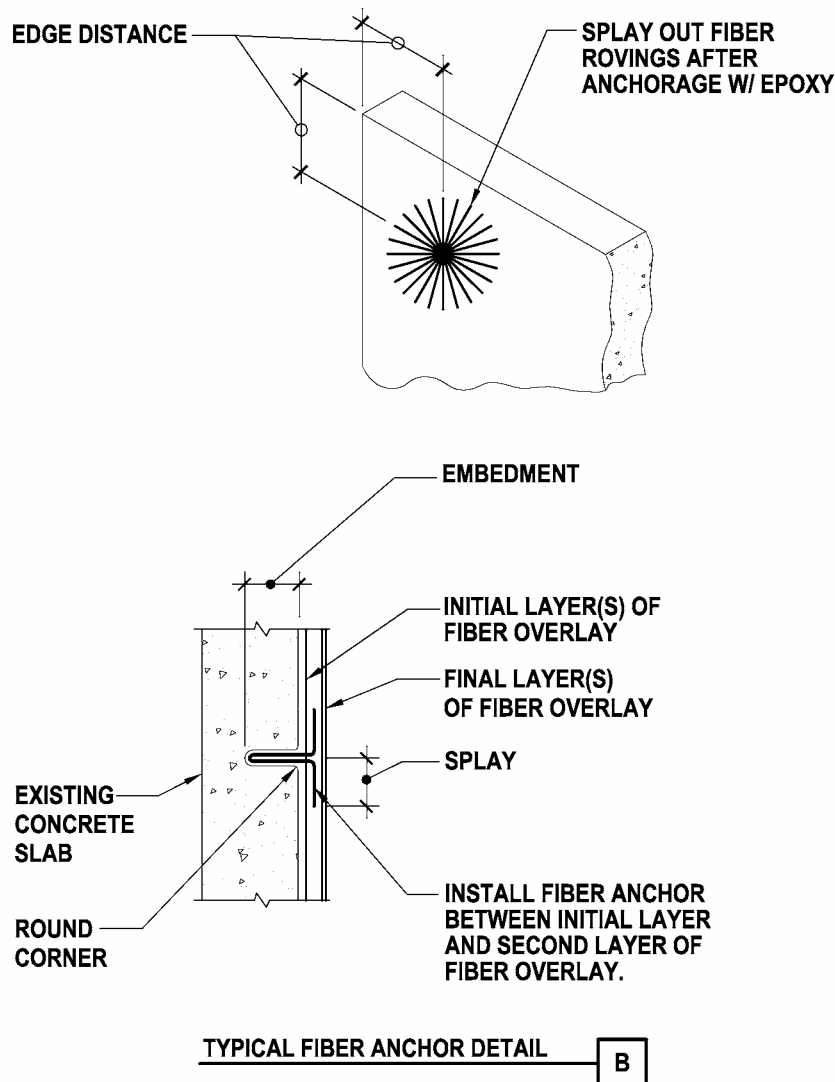
Figure 13.4.1-1B: Fiber Anchor Details

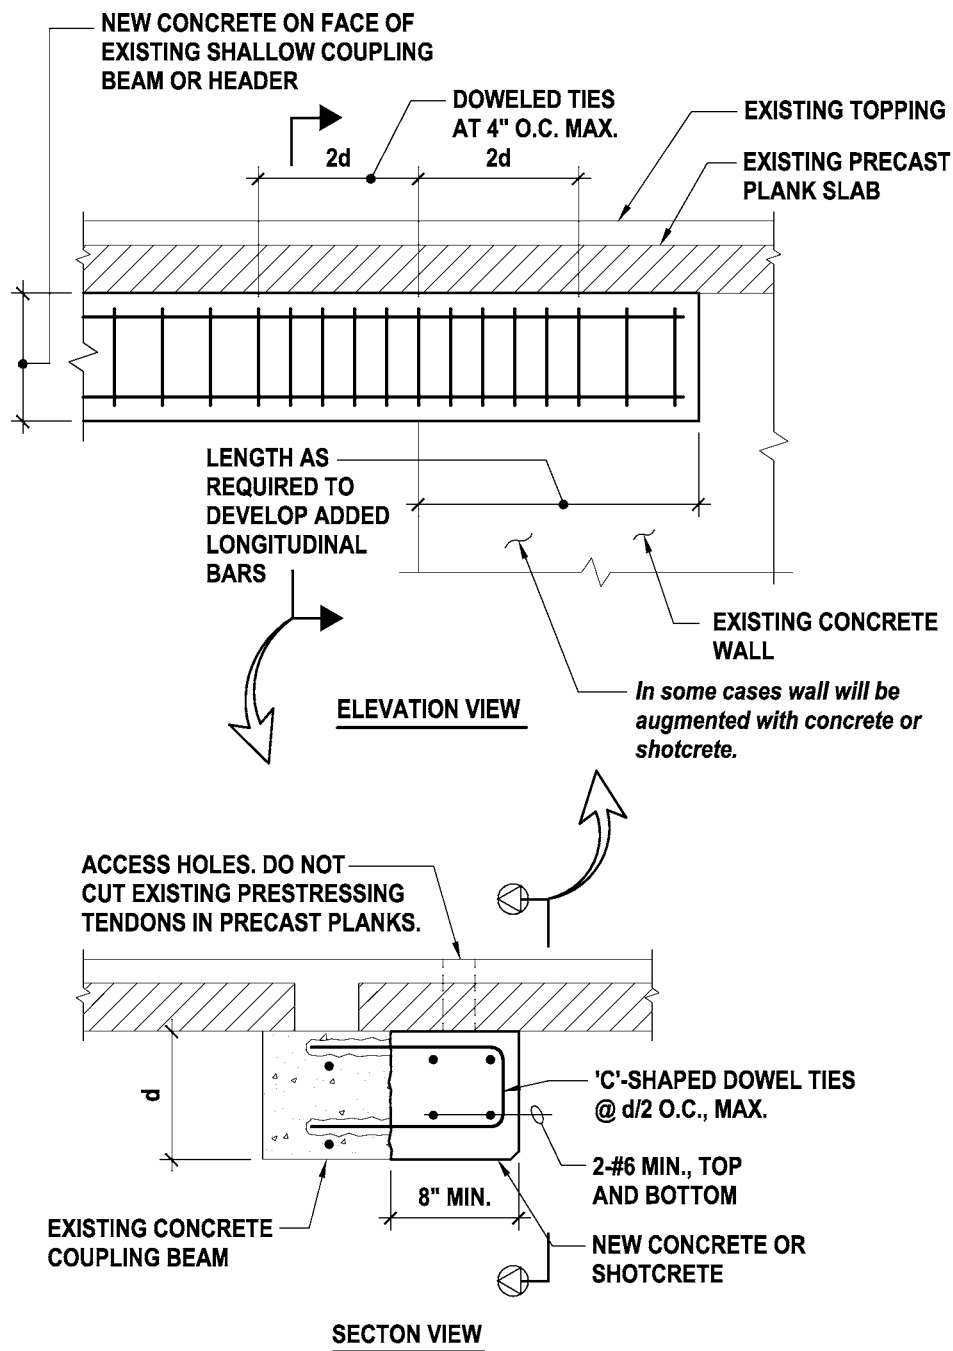
Figure 13.4.2-2: Typical Strengthening of Shallow Coupling Beam

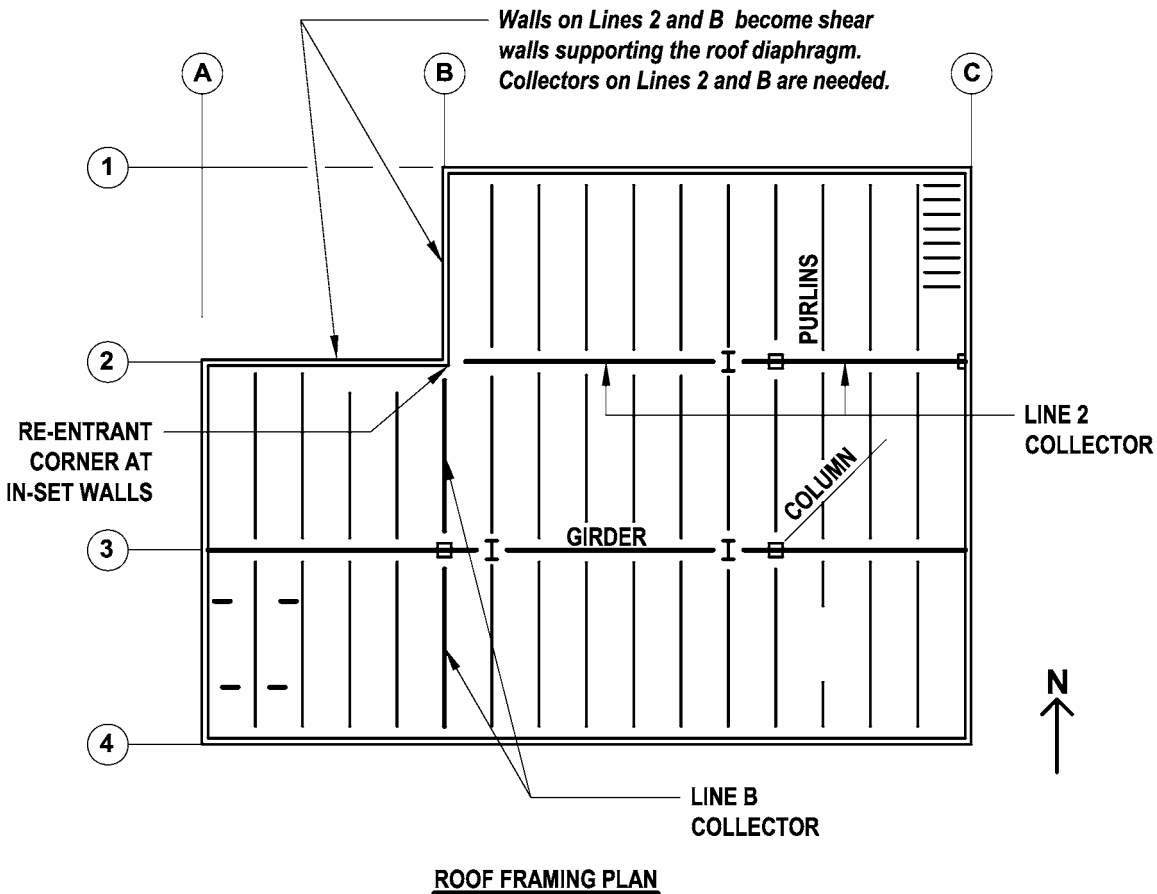
Figure 16.3-1: Plan of PC1 Building with Re-entrant Corner at In-set Panels

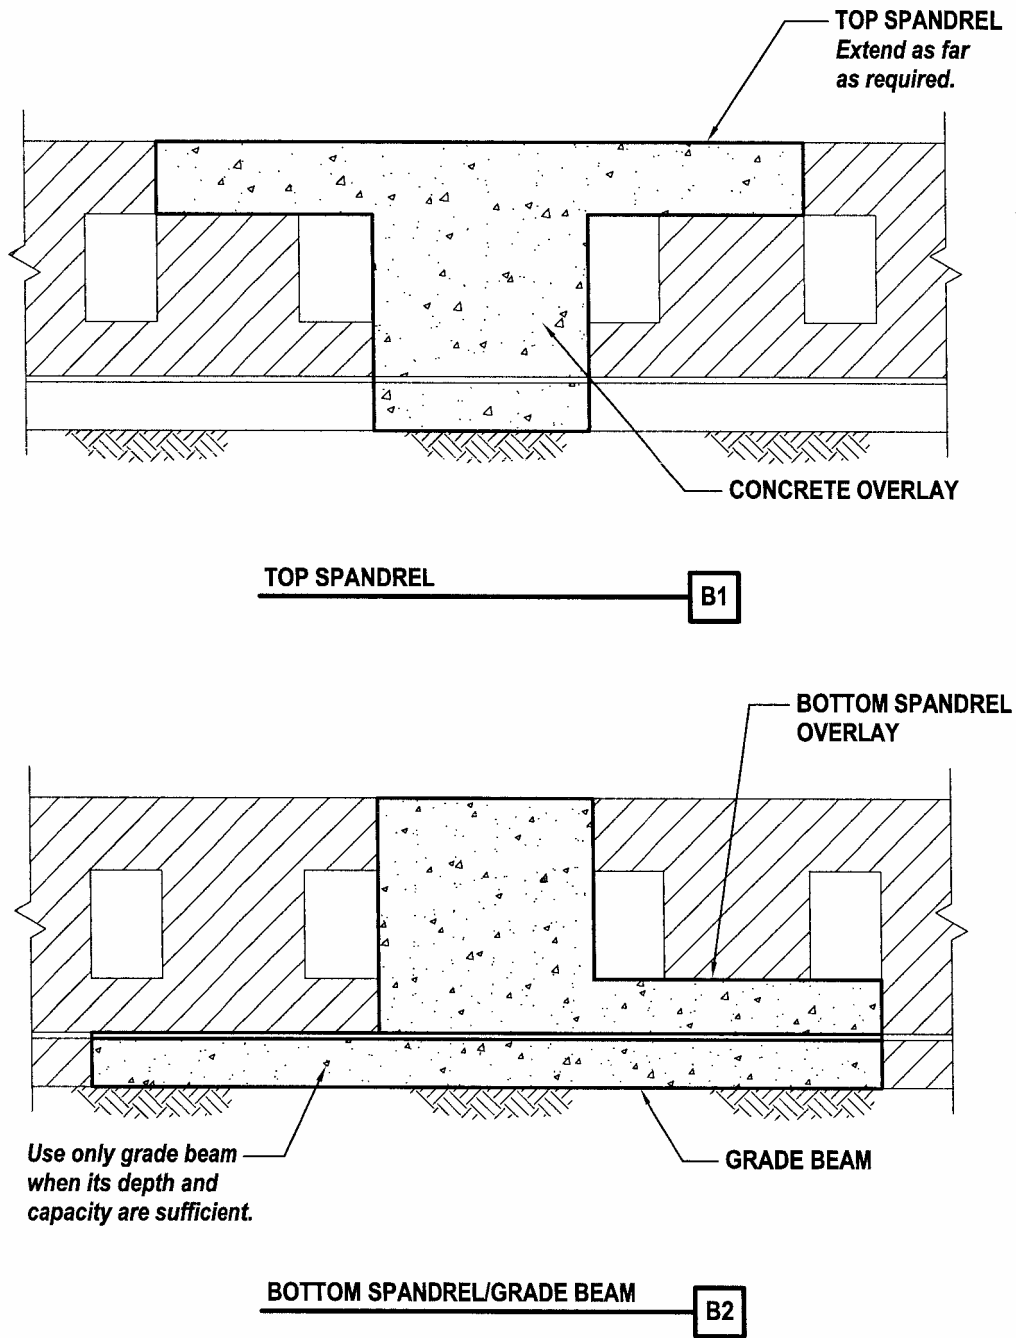
Figure 21.4.5-2B: Alternatives to Distribute Overturning Loads in Concrete Overlay

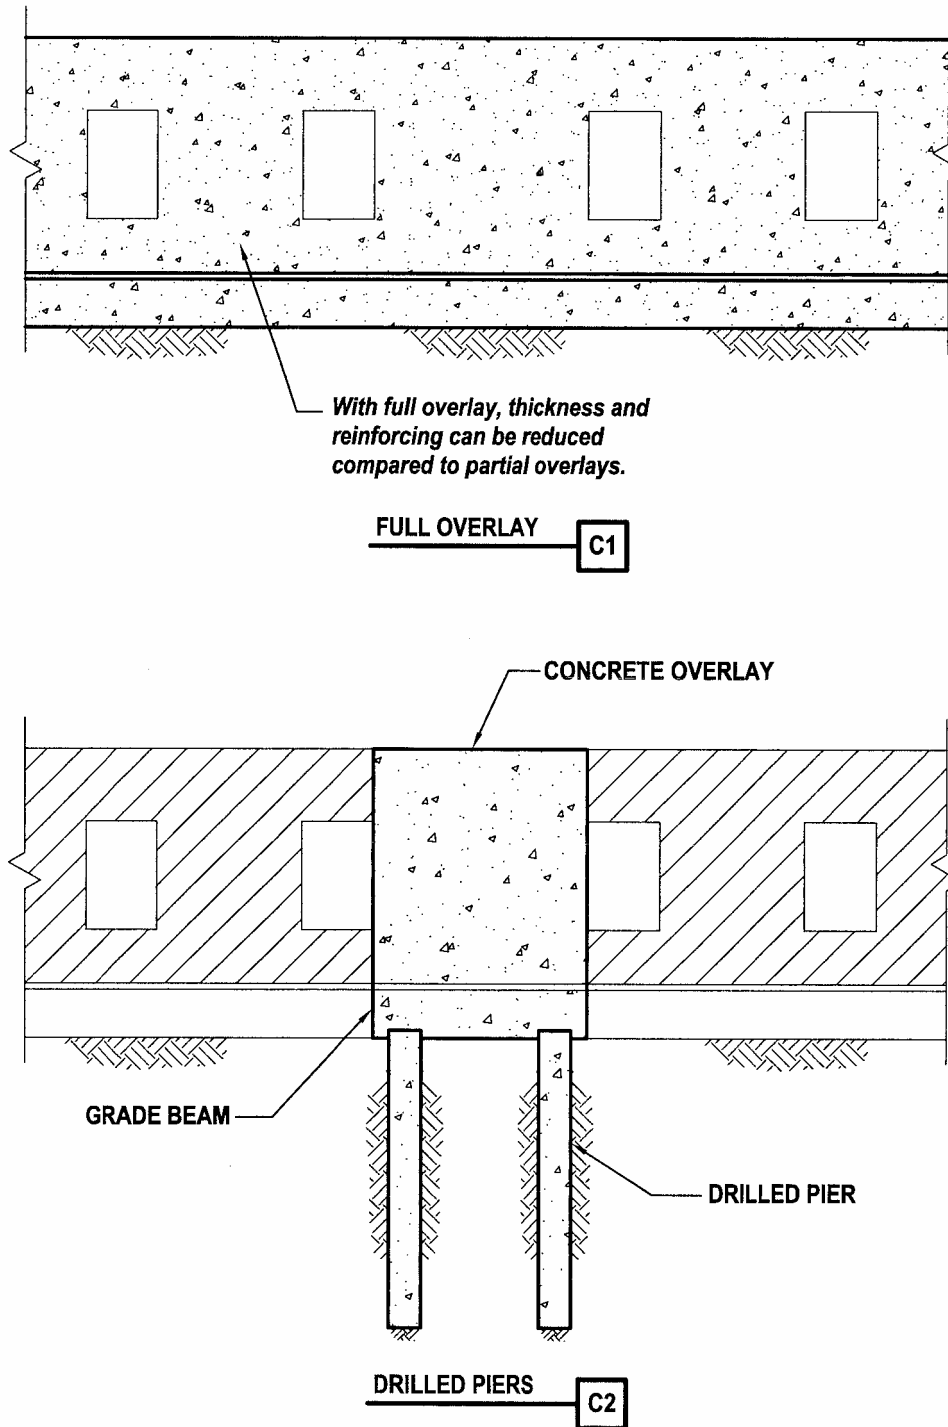
Figure 21.4.5-2C: Alternatives to Distribute Overturning Loads in Concrete Overlay

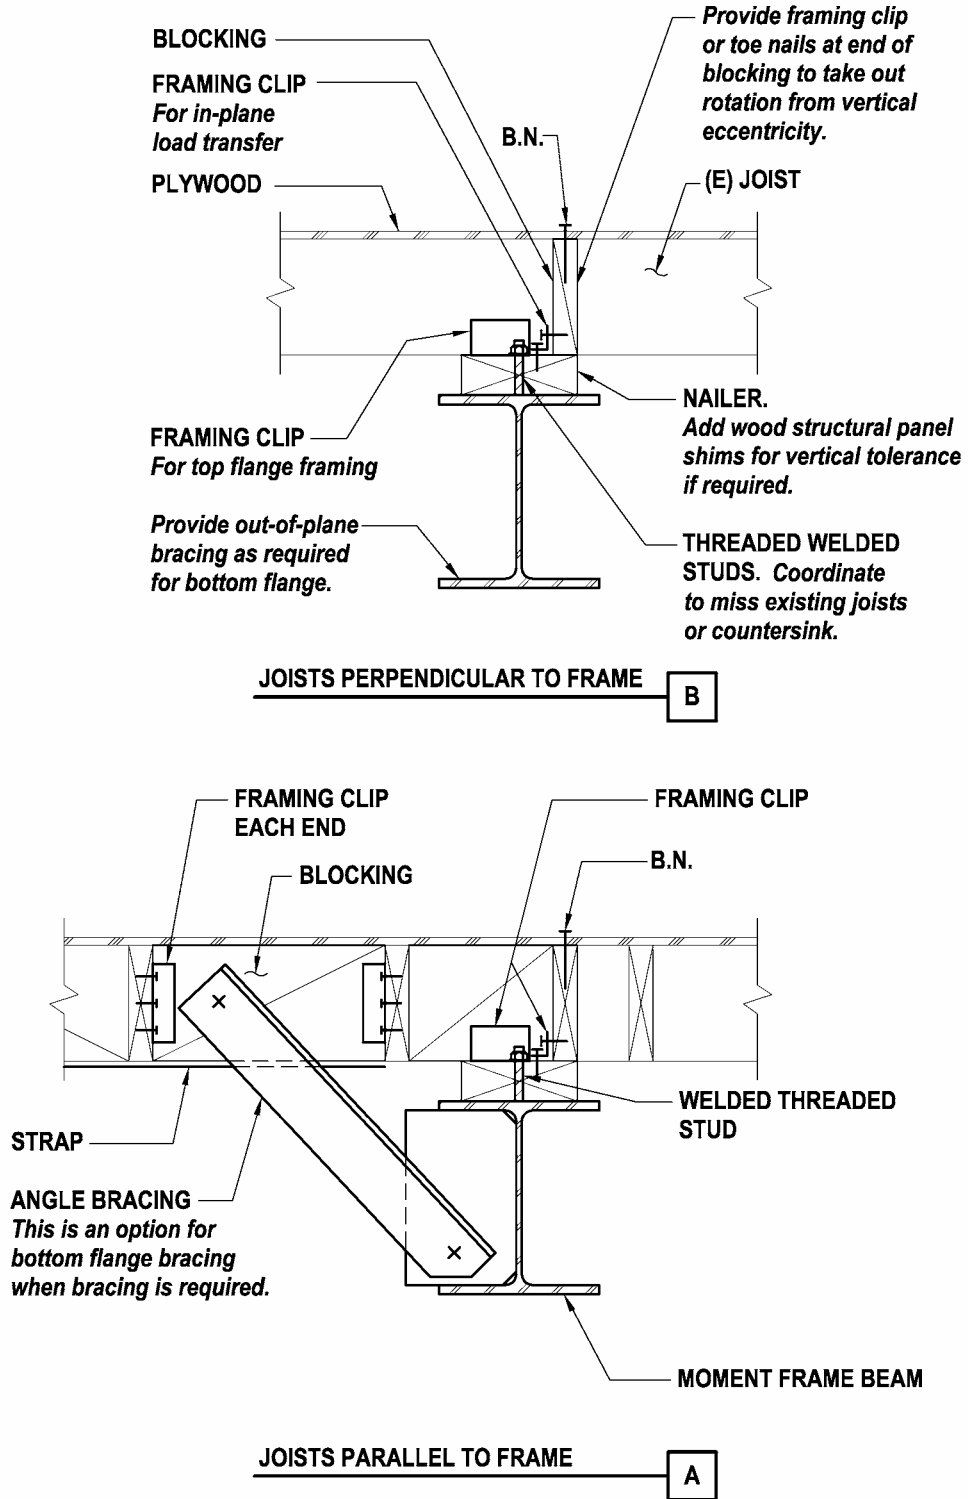
Figure 21.4.9-2: New Interior Steel Moment Frame to an Existing Wood Floor

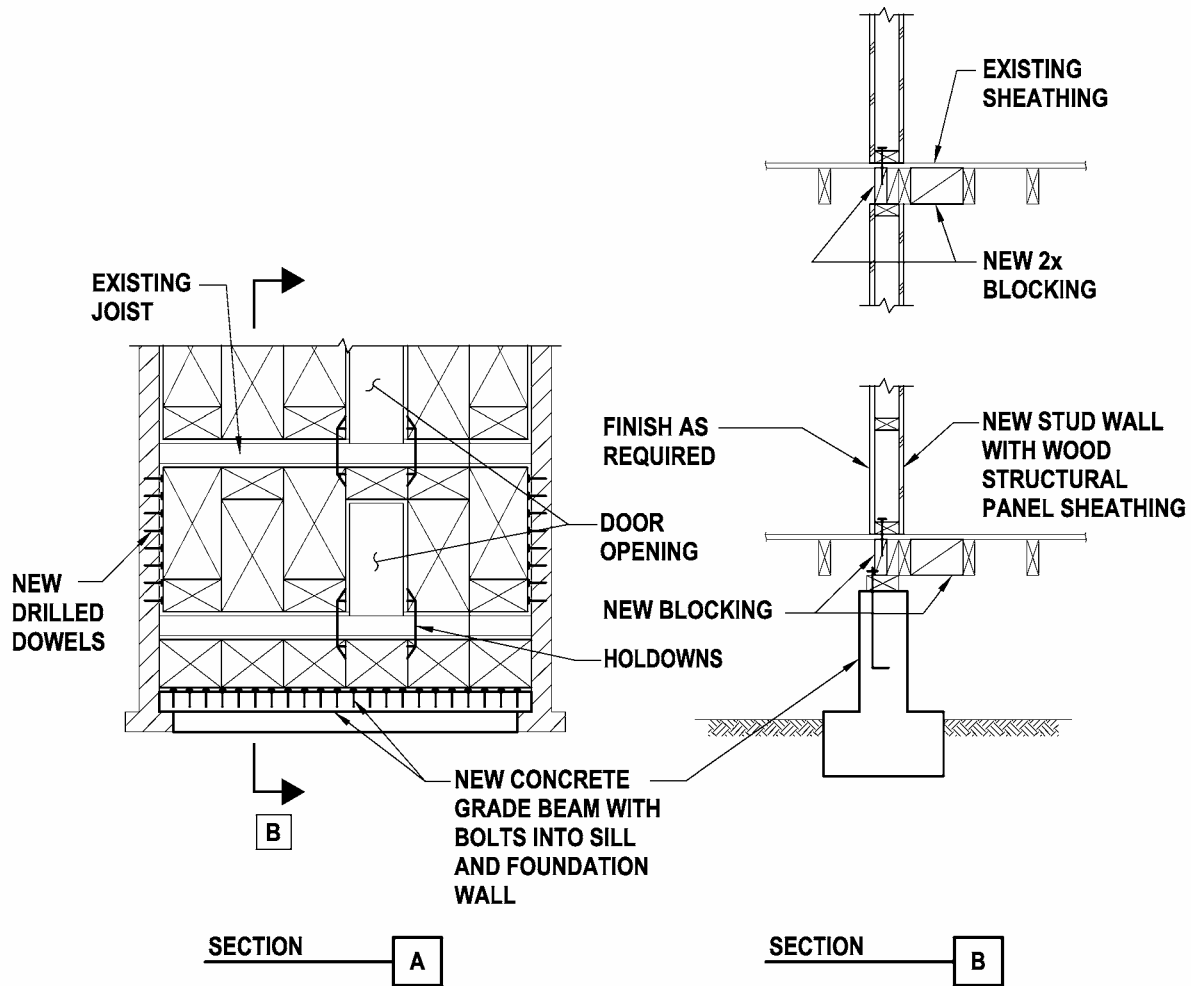
Figure 21.4.10-2: Add New Crosswalls

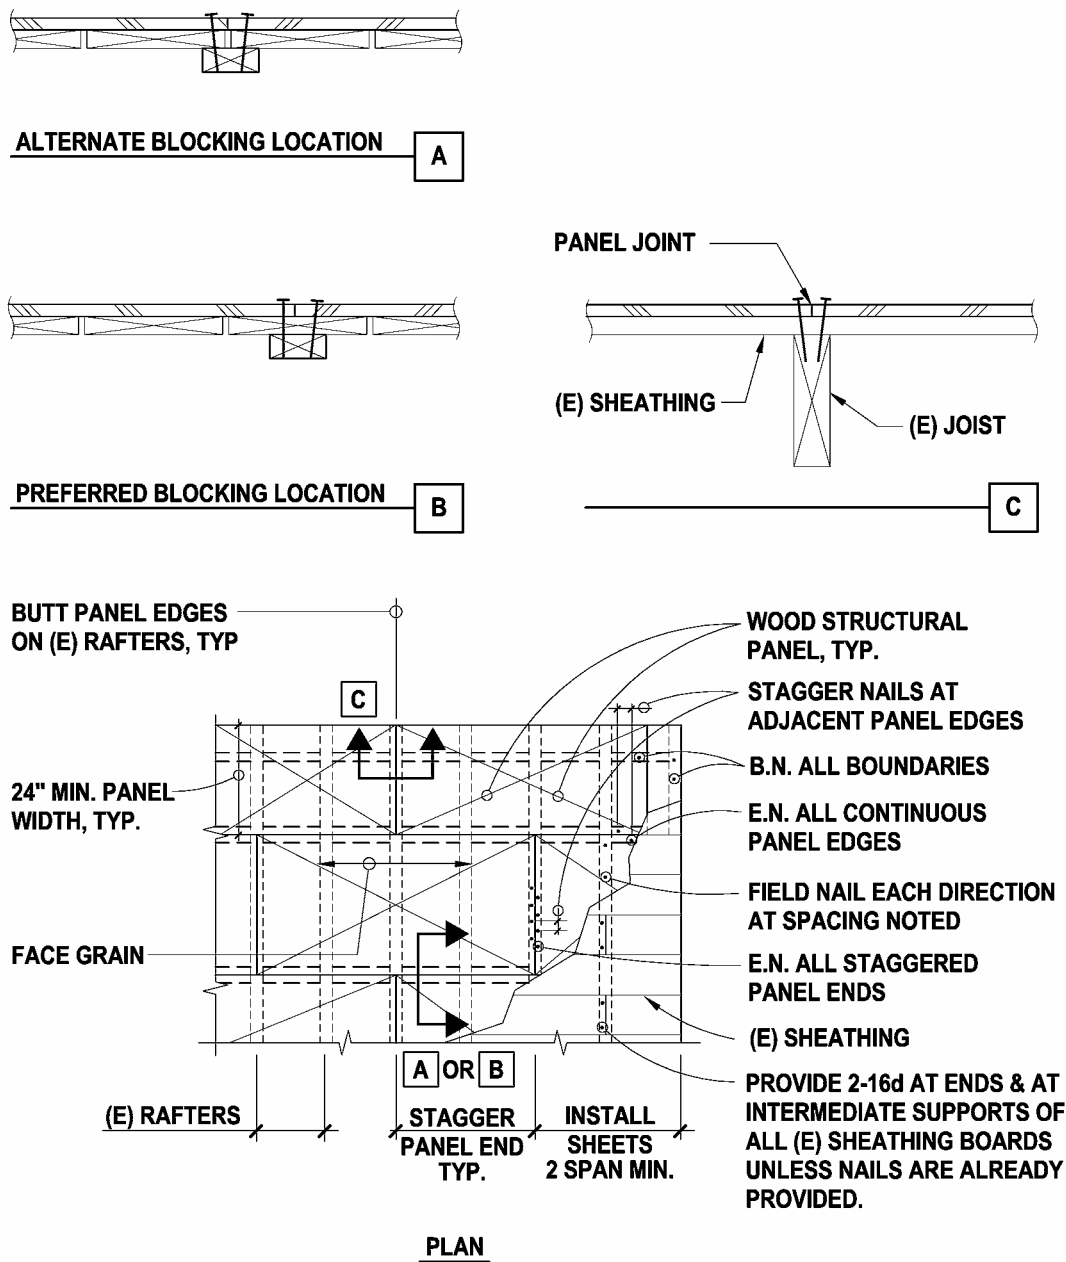
Figure 22.2.1-2: Wood Panel Overlay with Blocking Over Existing Sheathing

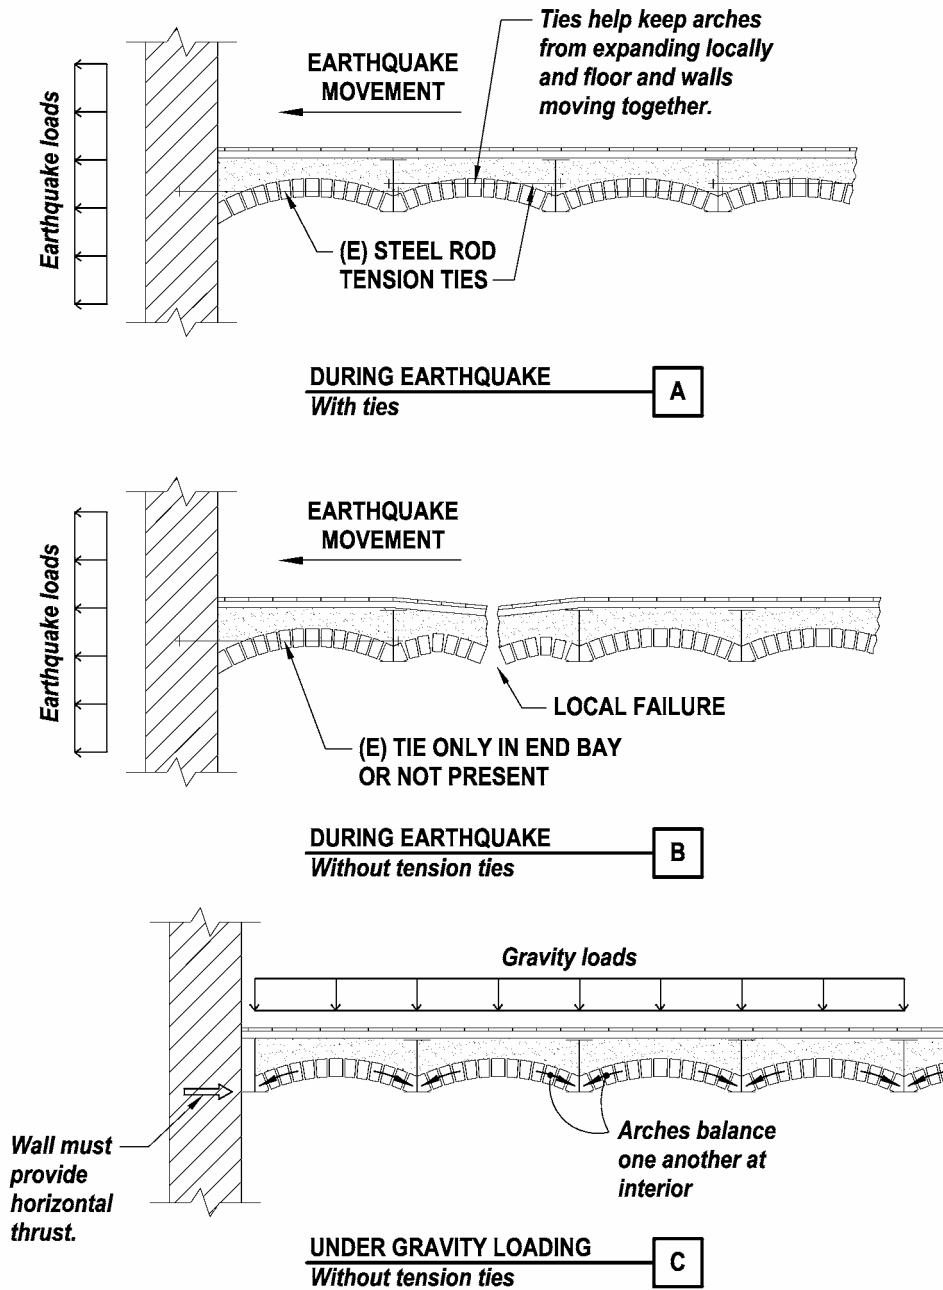
Figure 22.2.8-1: Failure Scenarios for Masonry Flat Arch Floors
