Techniques for the Seismic Rehabilitation of Existing Buildings

FEMA 547/2006 Edition

Rutherford & Chekene (R & C) Consulting Engineers (Subconsultant) under contract with National Institute of Standards and Technology (NIST).

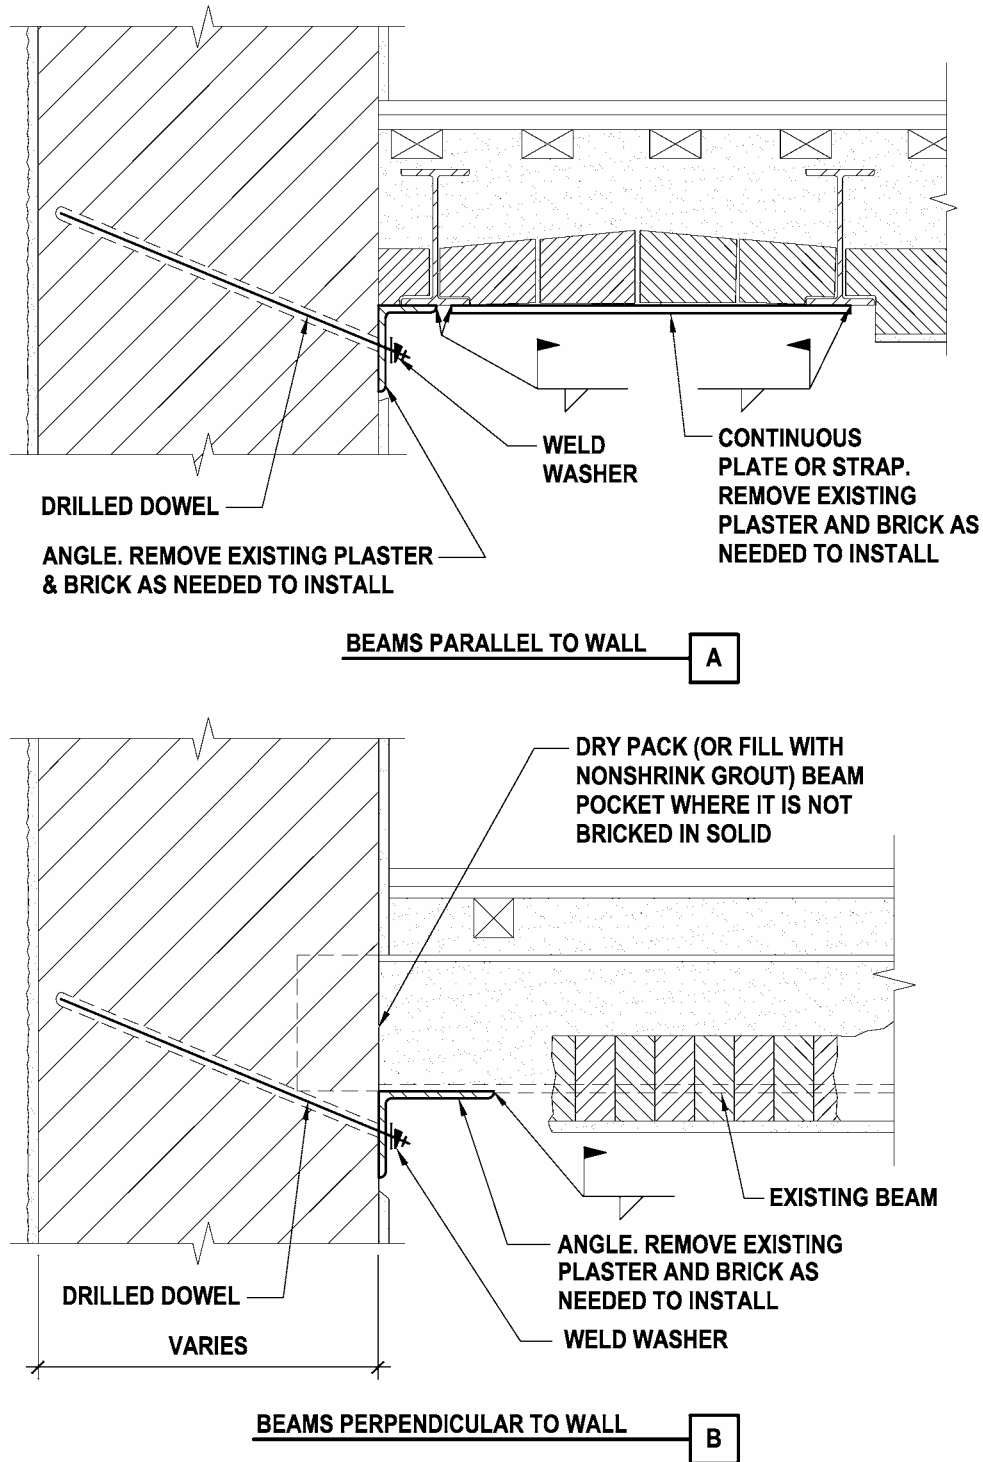
Figure 22.2.8-2: Add Wall-to-Diaphragm Ties and Chord for Masonry Flat Arch Floor - Access from Below the Floor

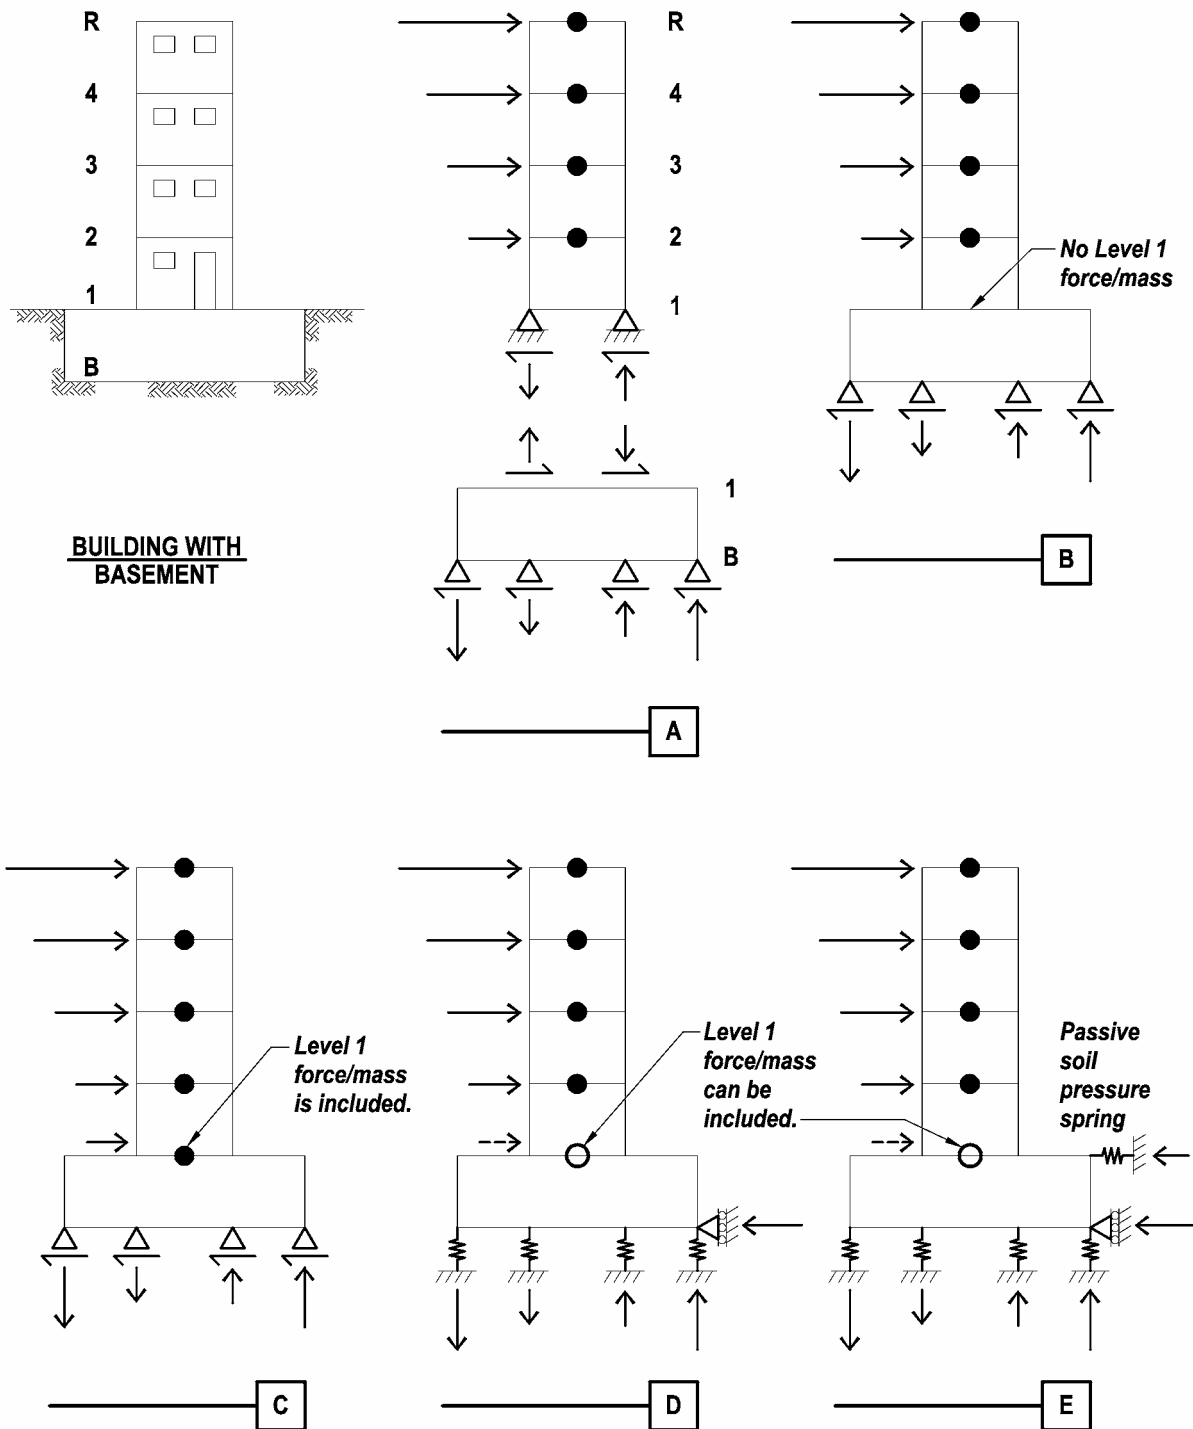
Figure 23.4-1: Modeling Approaches for Buildings with Basements

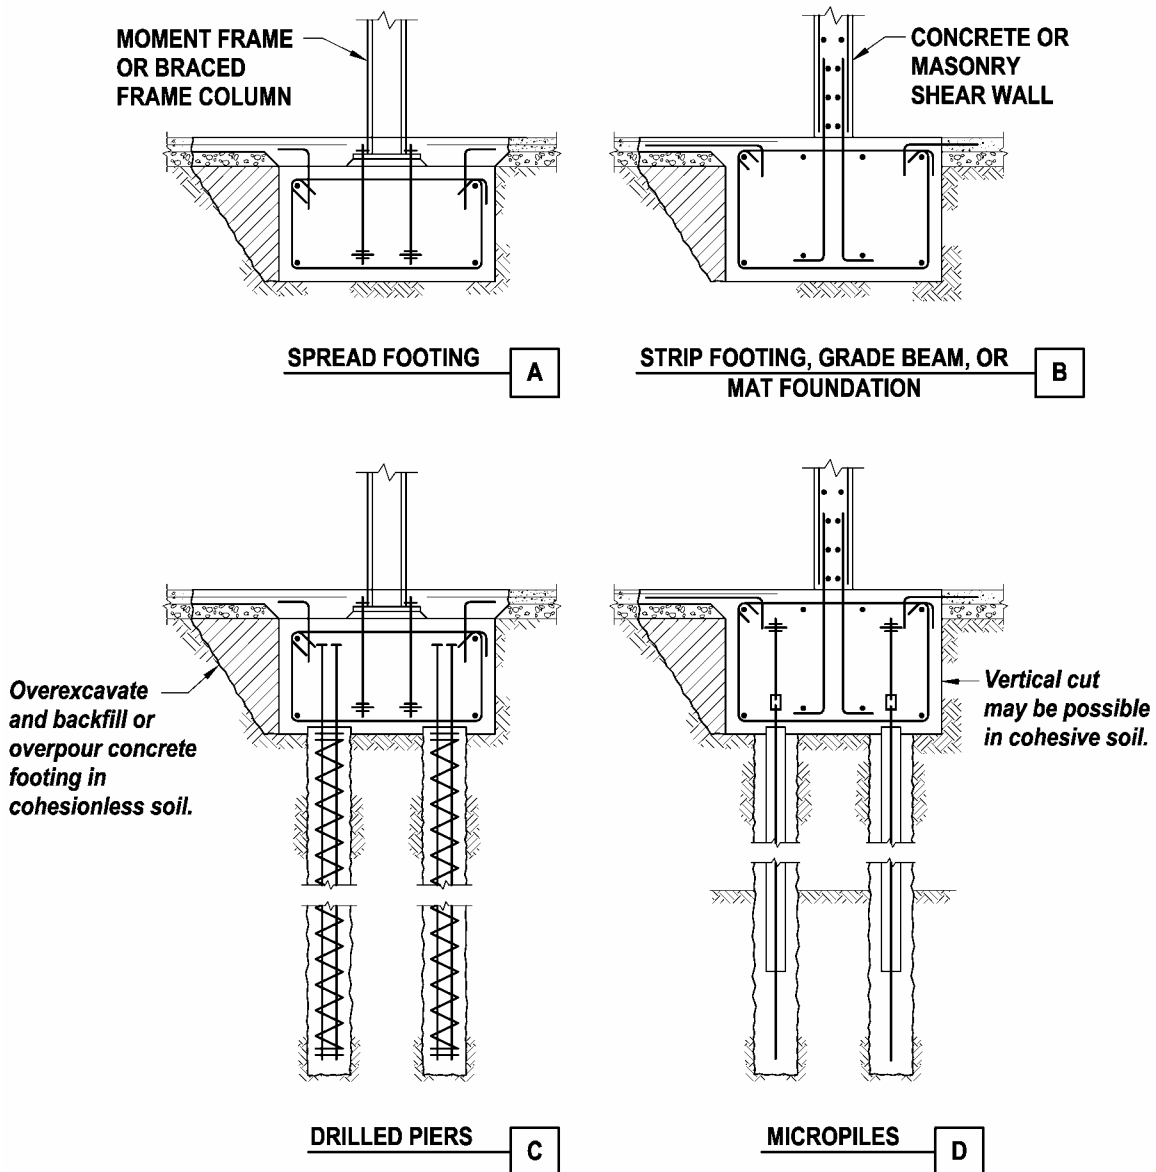
Figure 23.6.1-1: Types of New Foundations Commonly Used in Seismic Rehabilitation

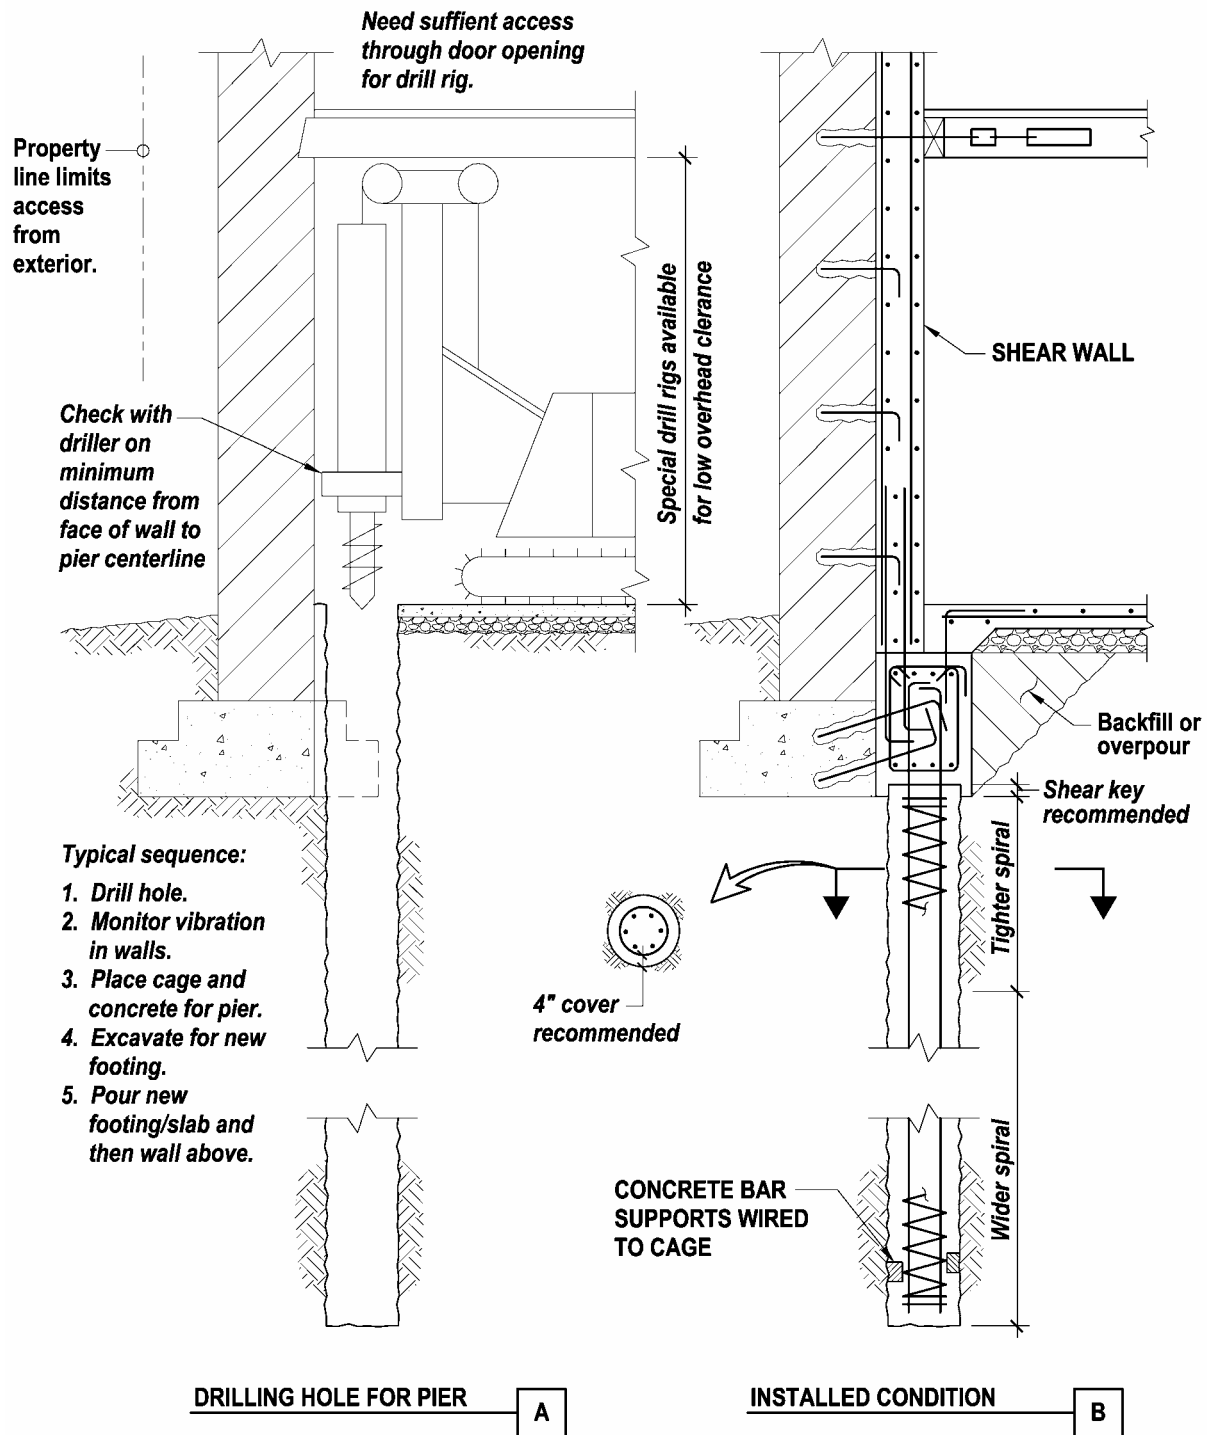
Figure 23.6.4-1: New Drilled Pier Next to Existing Strip Foundation

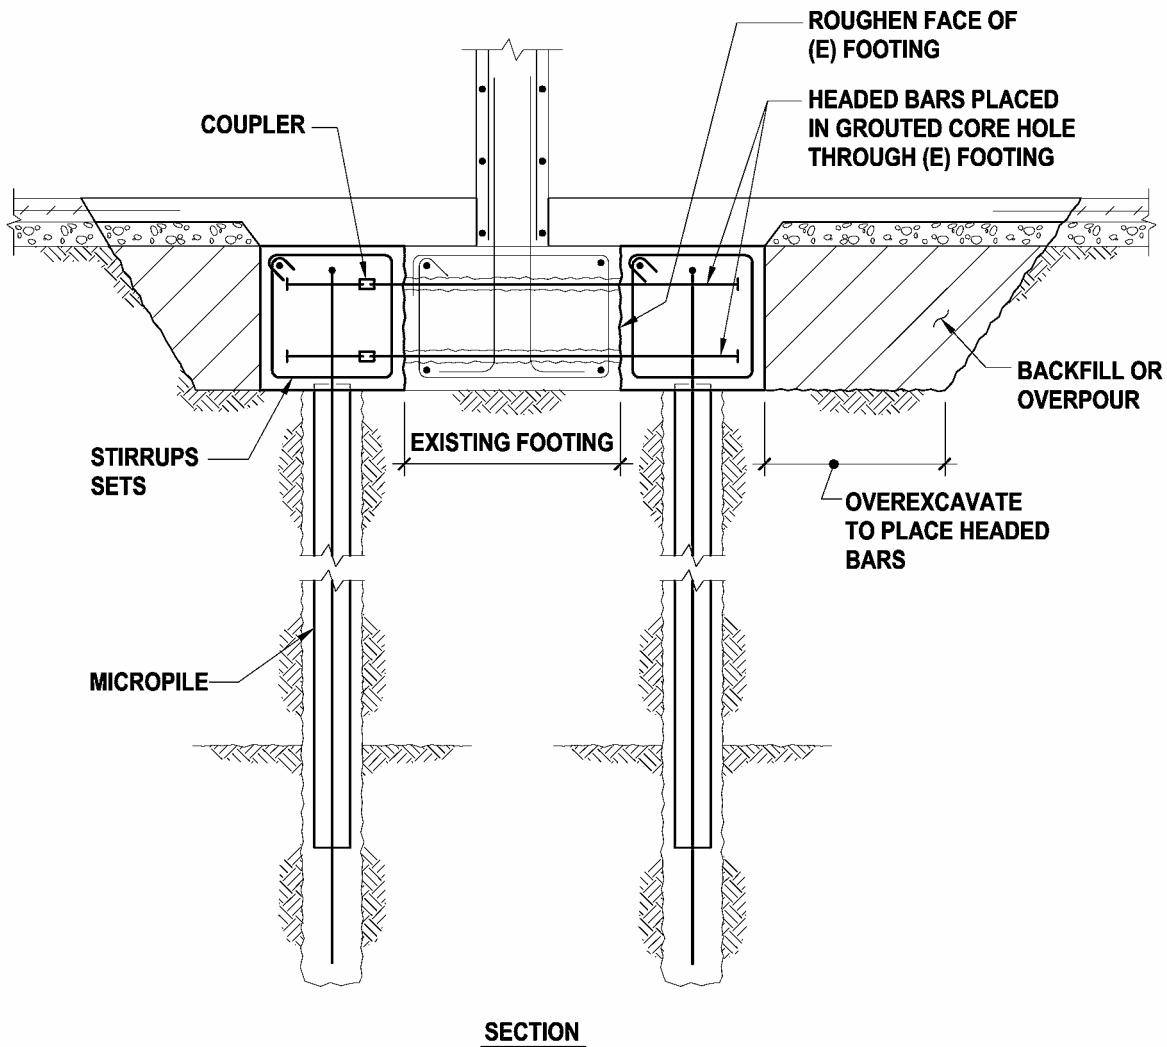
Figure 23.7.2.-1: Micropile Enhancement to Existing Strip Footing

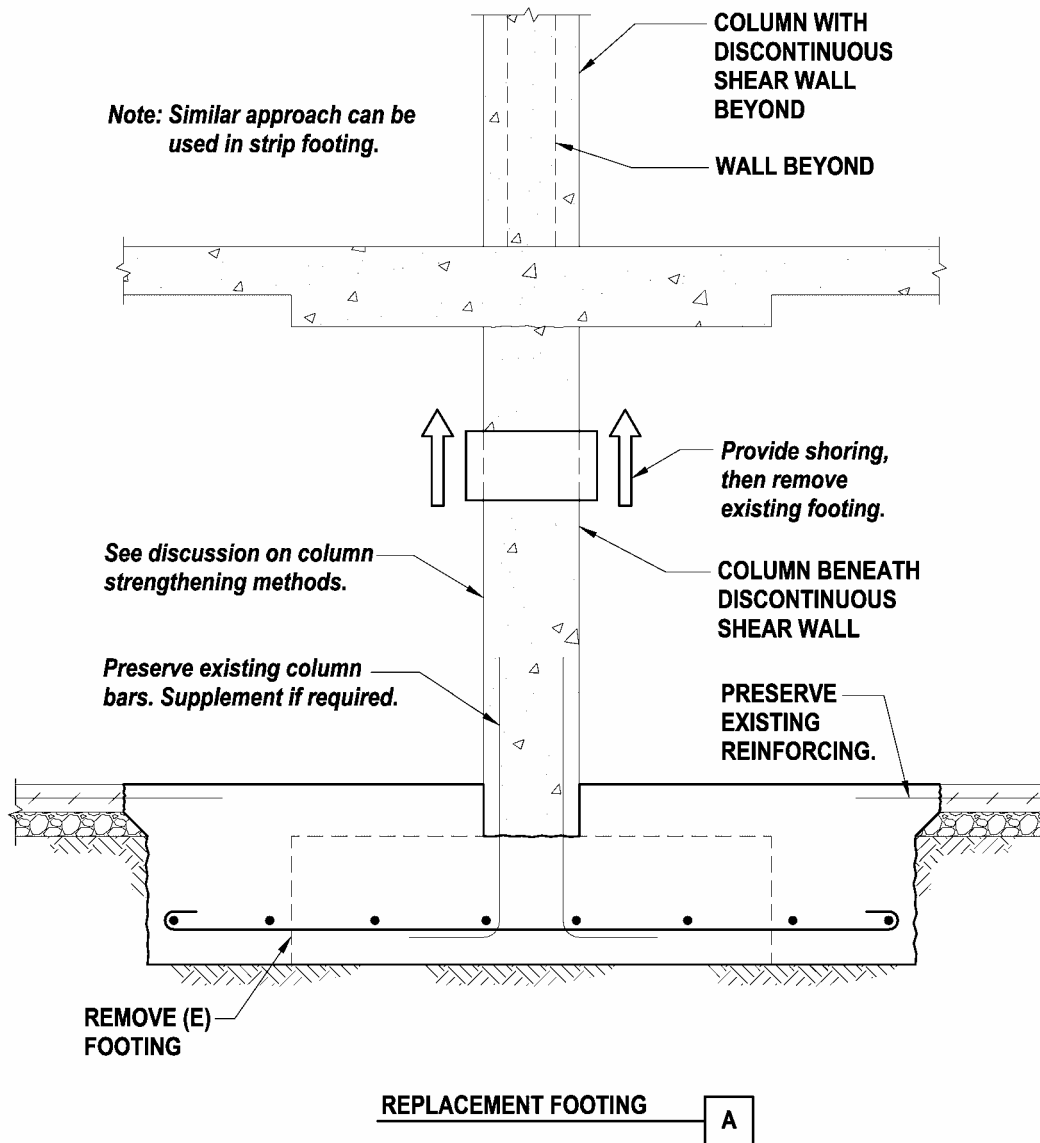
Figure 23.7.3-2: Replace Existing Spread Footing

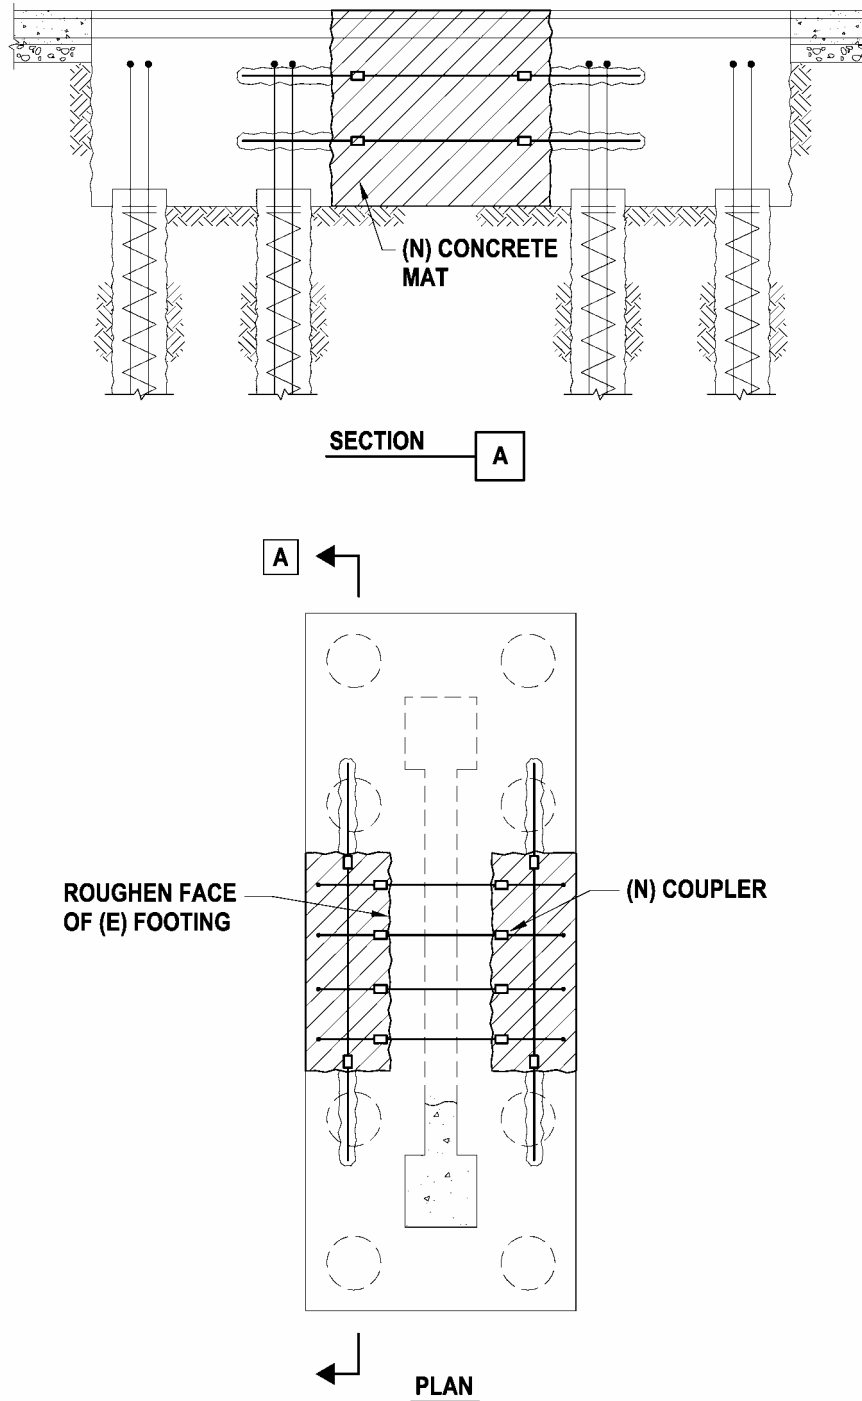
Figure 23.8.2-1: New Mat Foundation Between Existing Drilled Piers

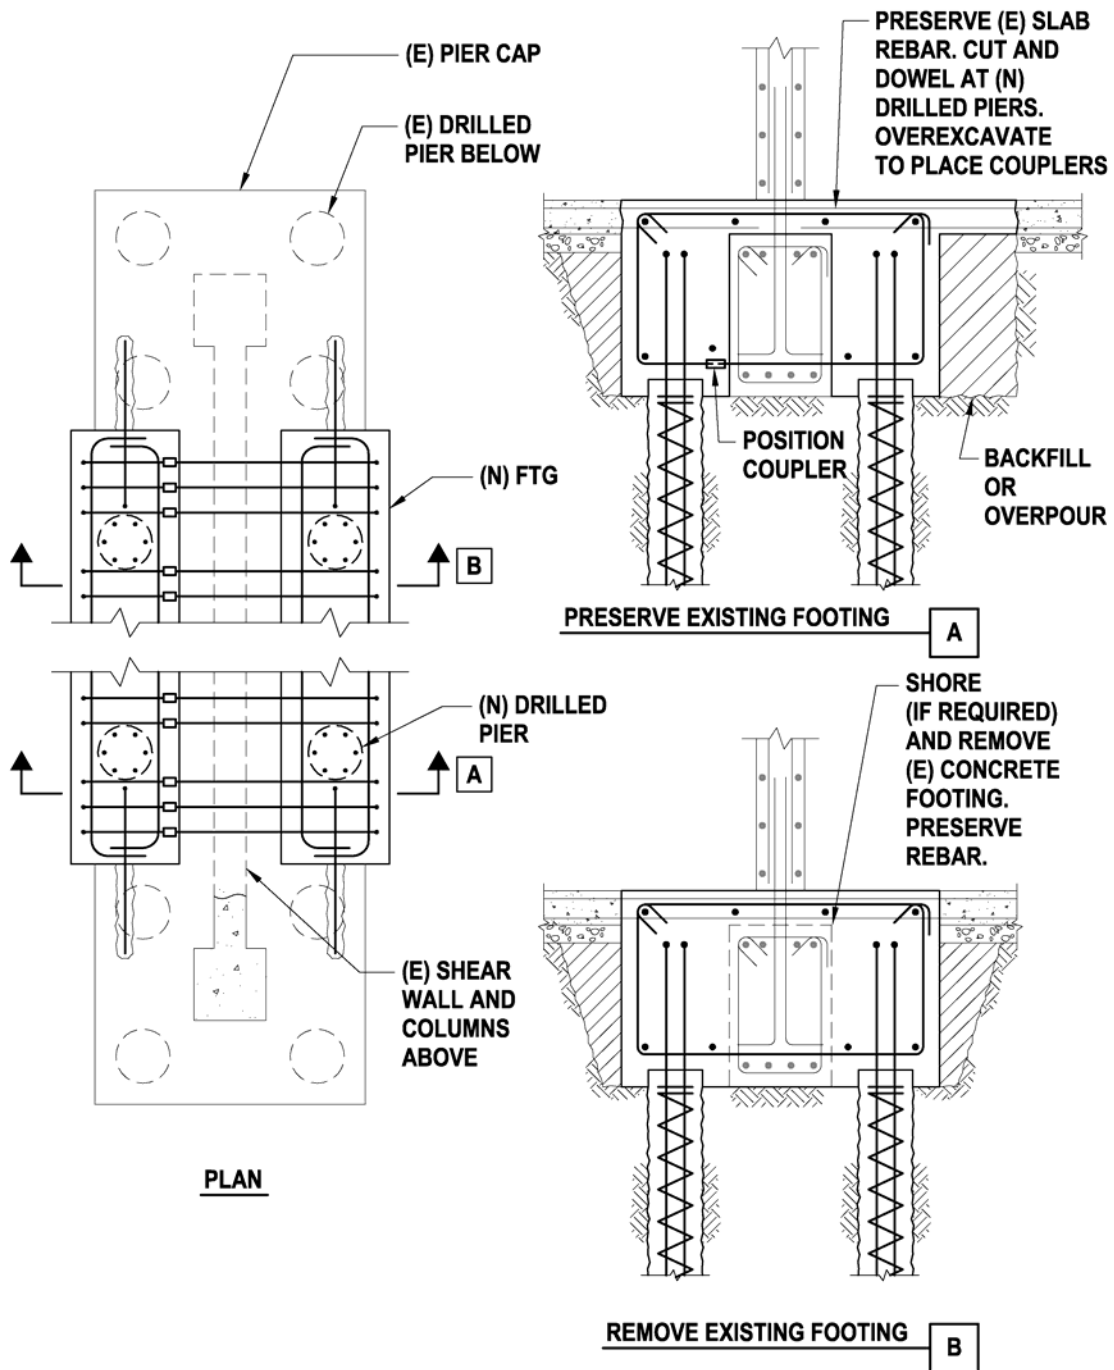
Figure 23.8.3.-1: Adding Drilled Piers to an Existing Drilled Pier Foundation

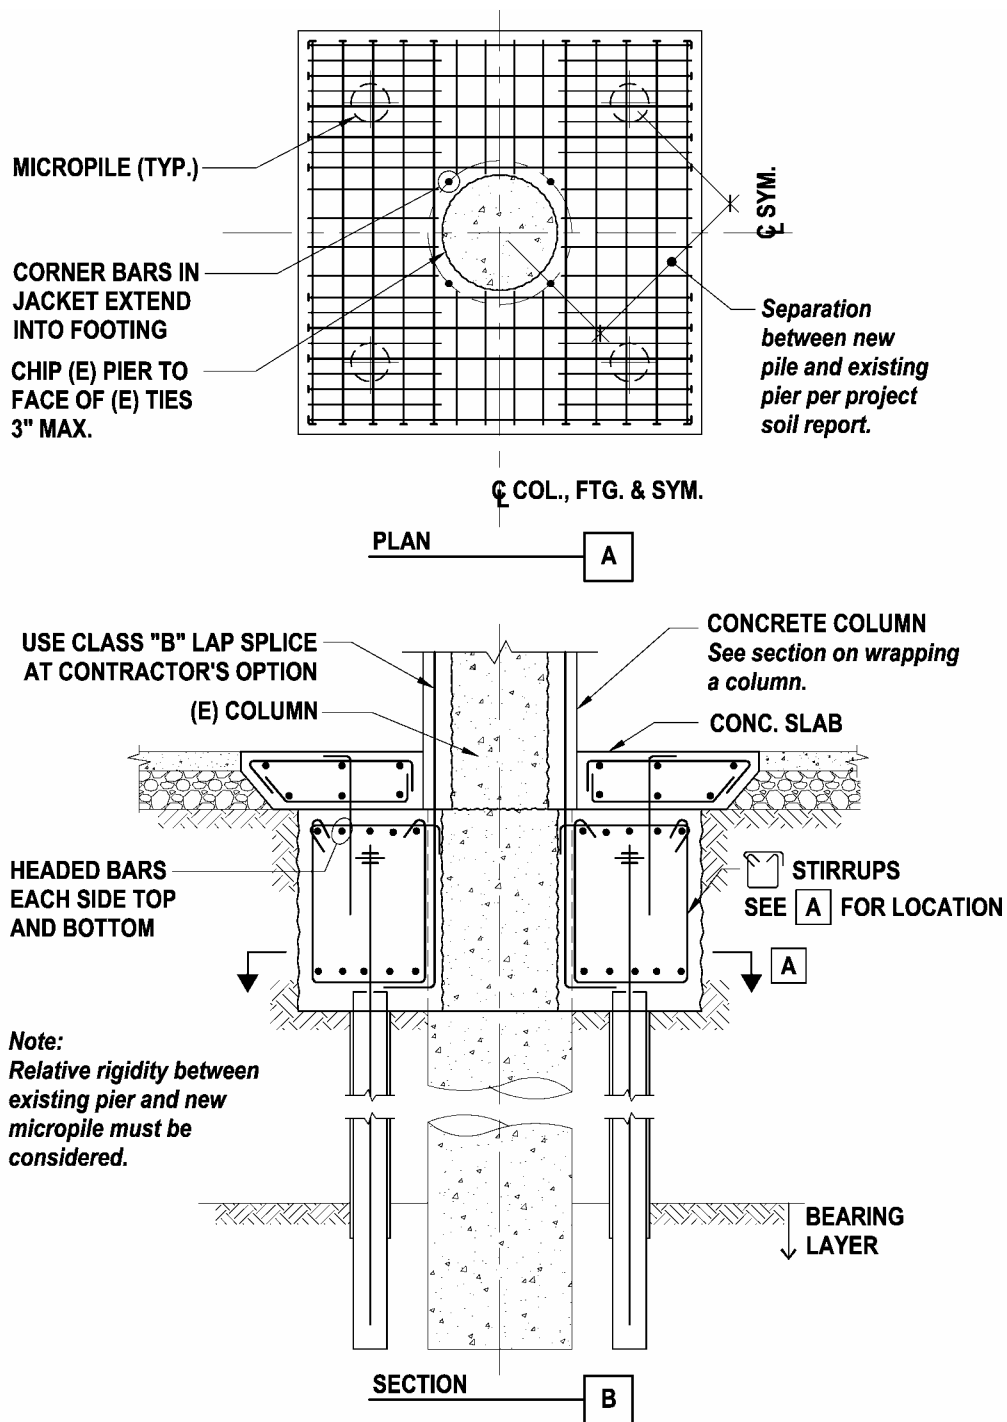
Figure 23.8.4.-1: Micropile Enhancement of an Existing Drilled Pier Footing

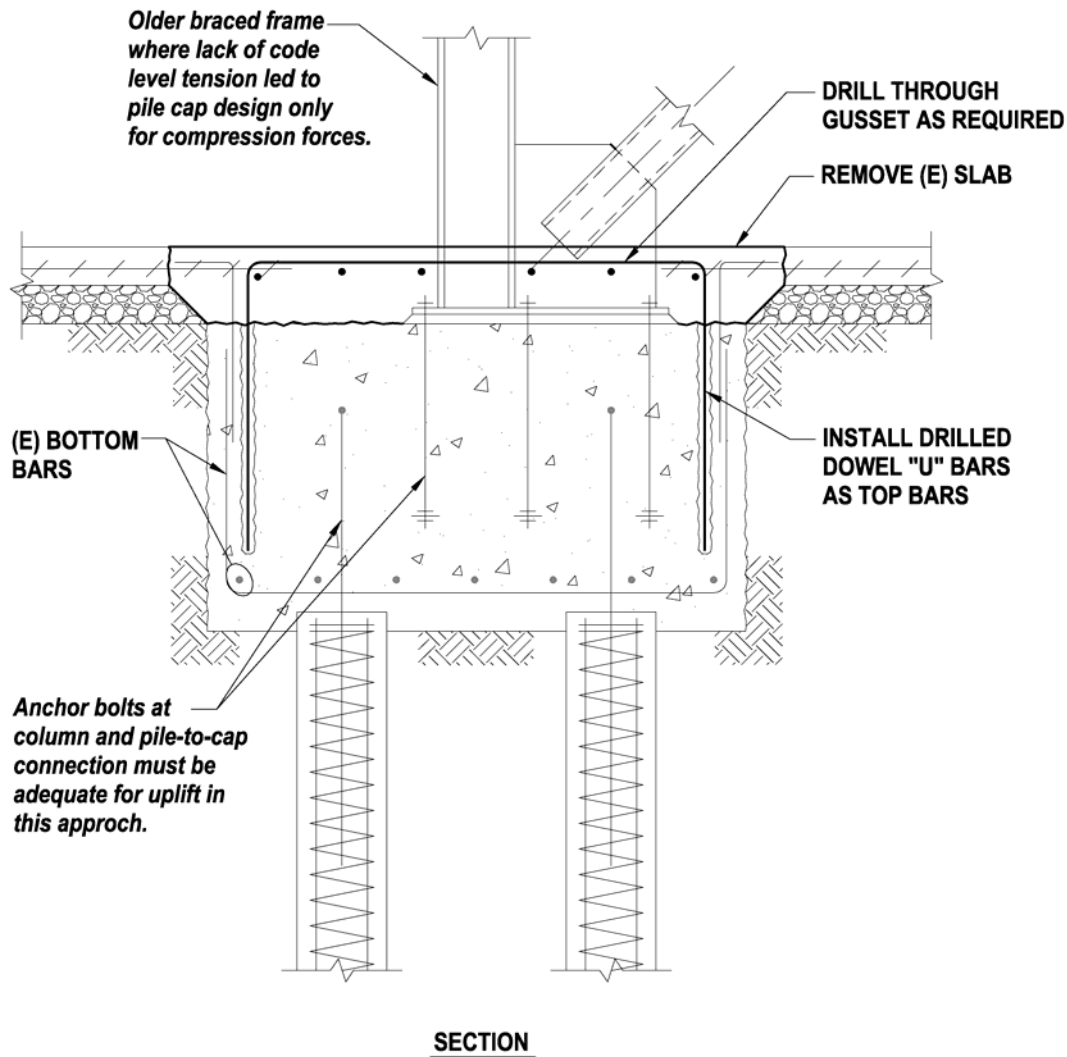
Figure 23.8.5-1: Adding Top Bars to an Existing Pile Cap

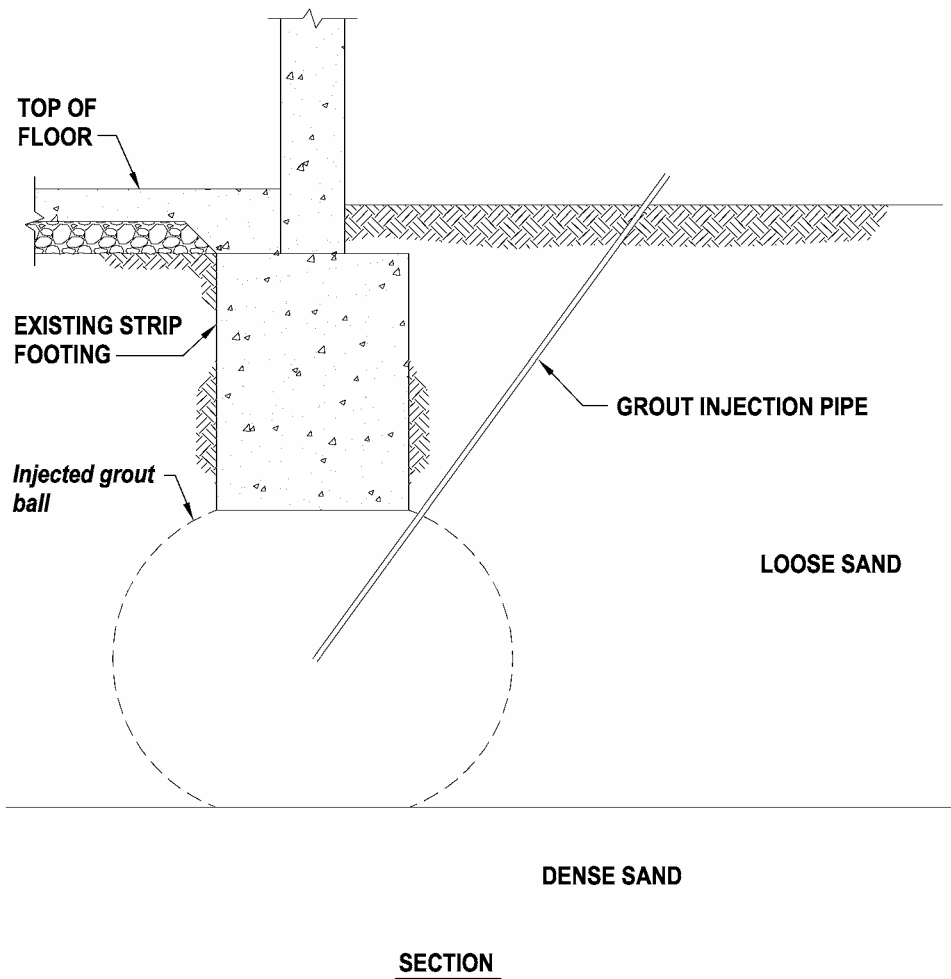
Figure 23.9.3-1: Permeation Grouting of Loose Sand Under Existing Shallow Foundation

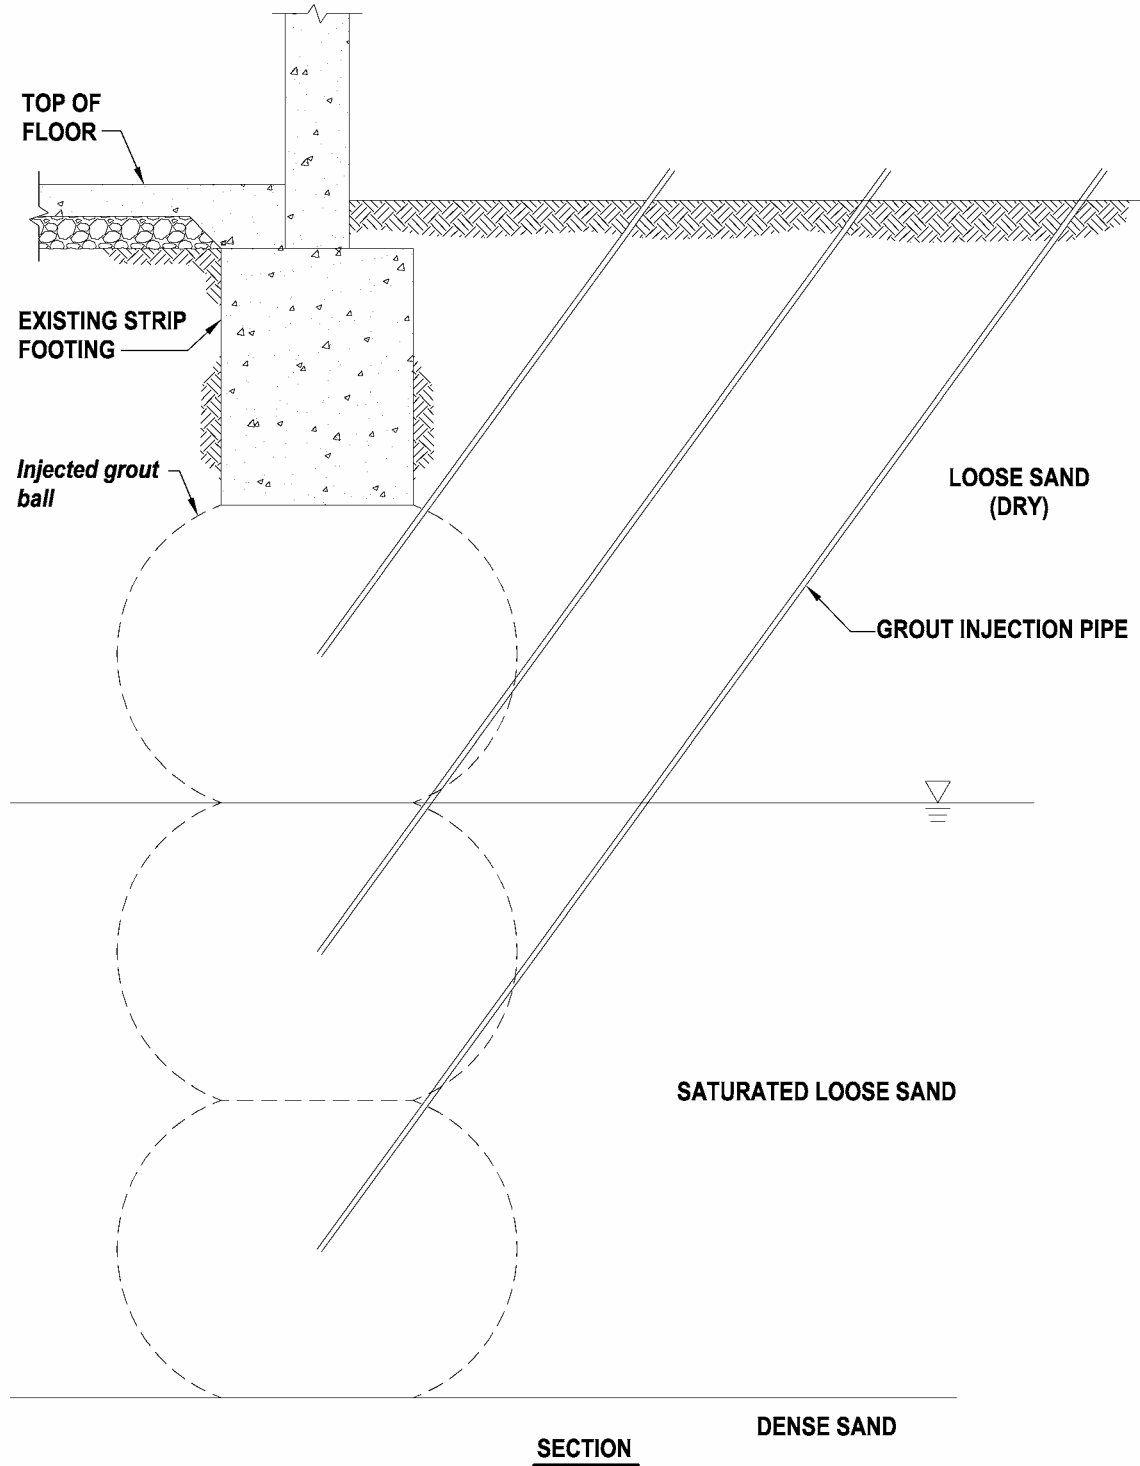
Figure 23.9.3-2: Permeation Grouting of Liquefiable Layer Under Existing Shallow Foundation

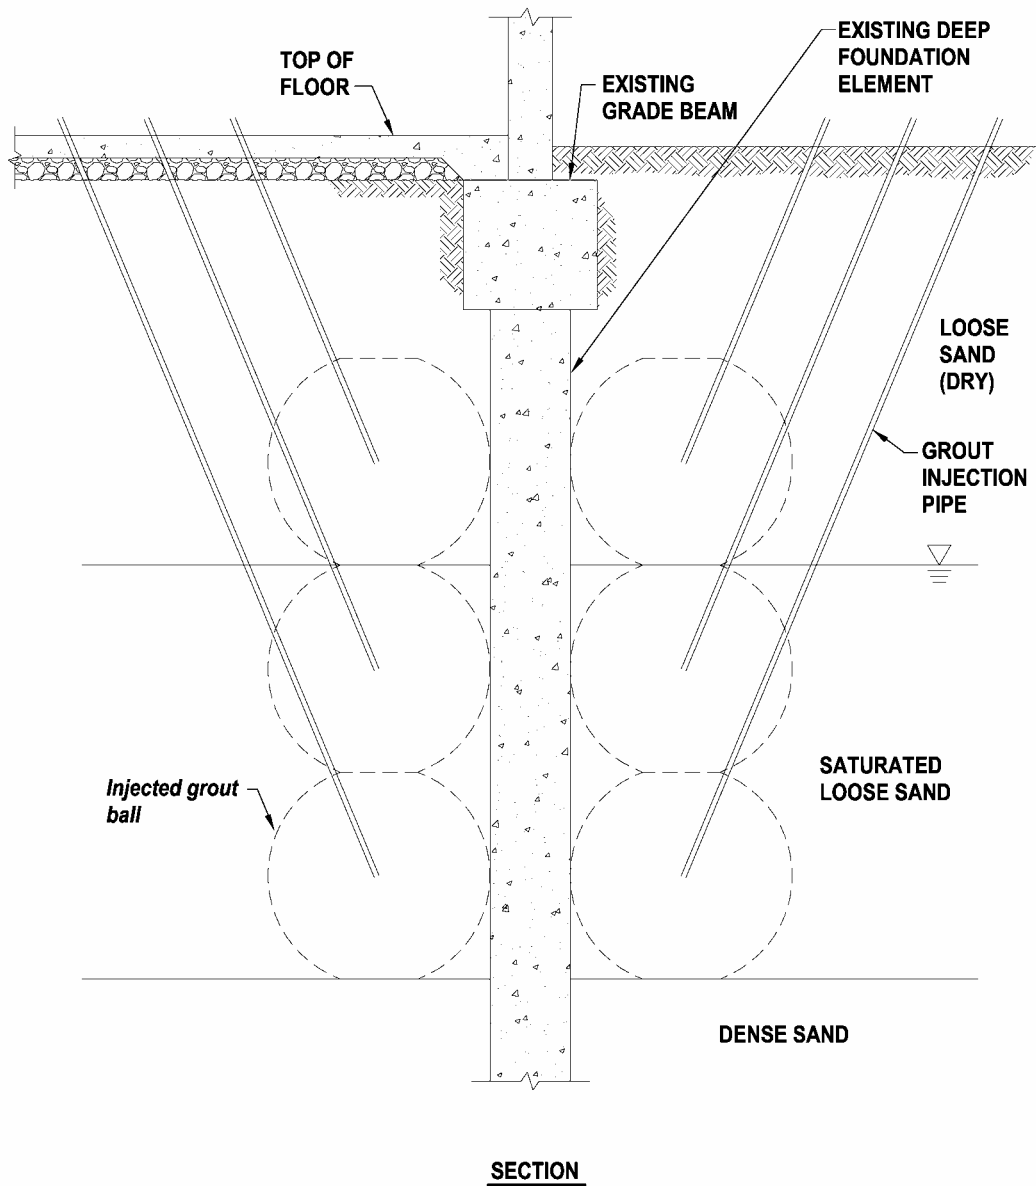
**Figure 23.9.3-3: Permeation Grouting of Liquefiable Layer
Around Existing Deep Foundation**

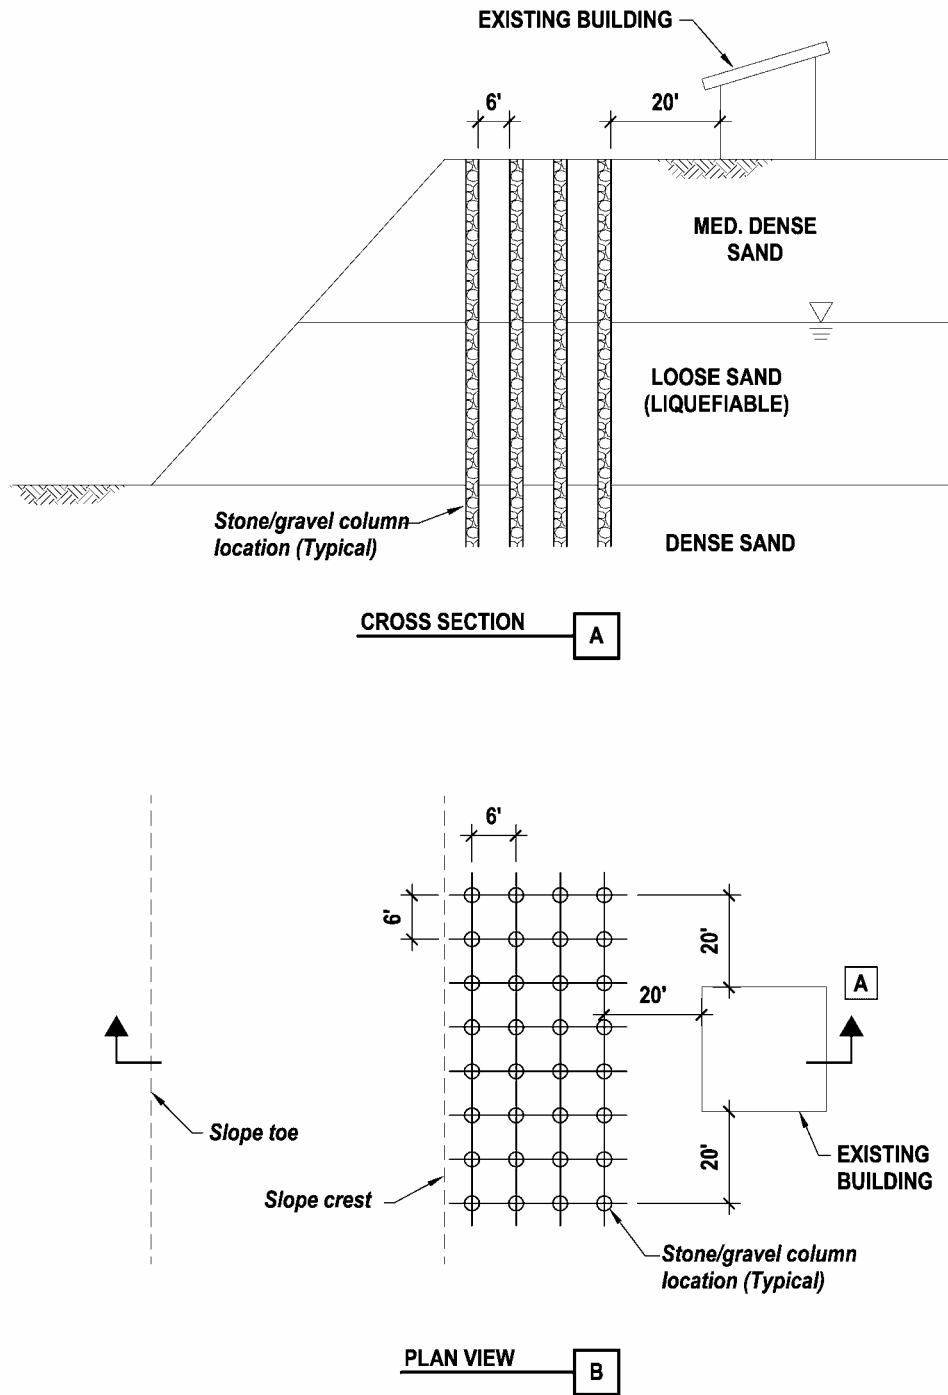
Figure 23.10.3-2: Mitigation Measure for Lateral Spreading – Stone/Gravel Column

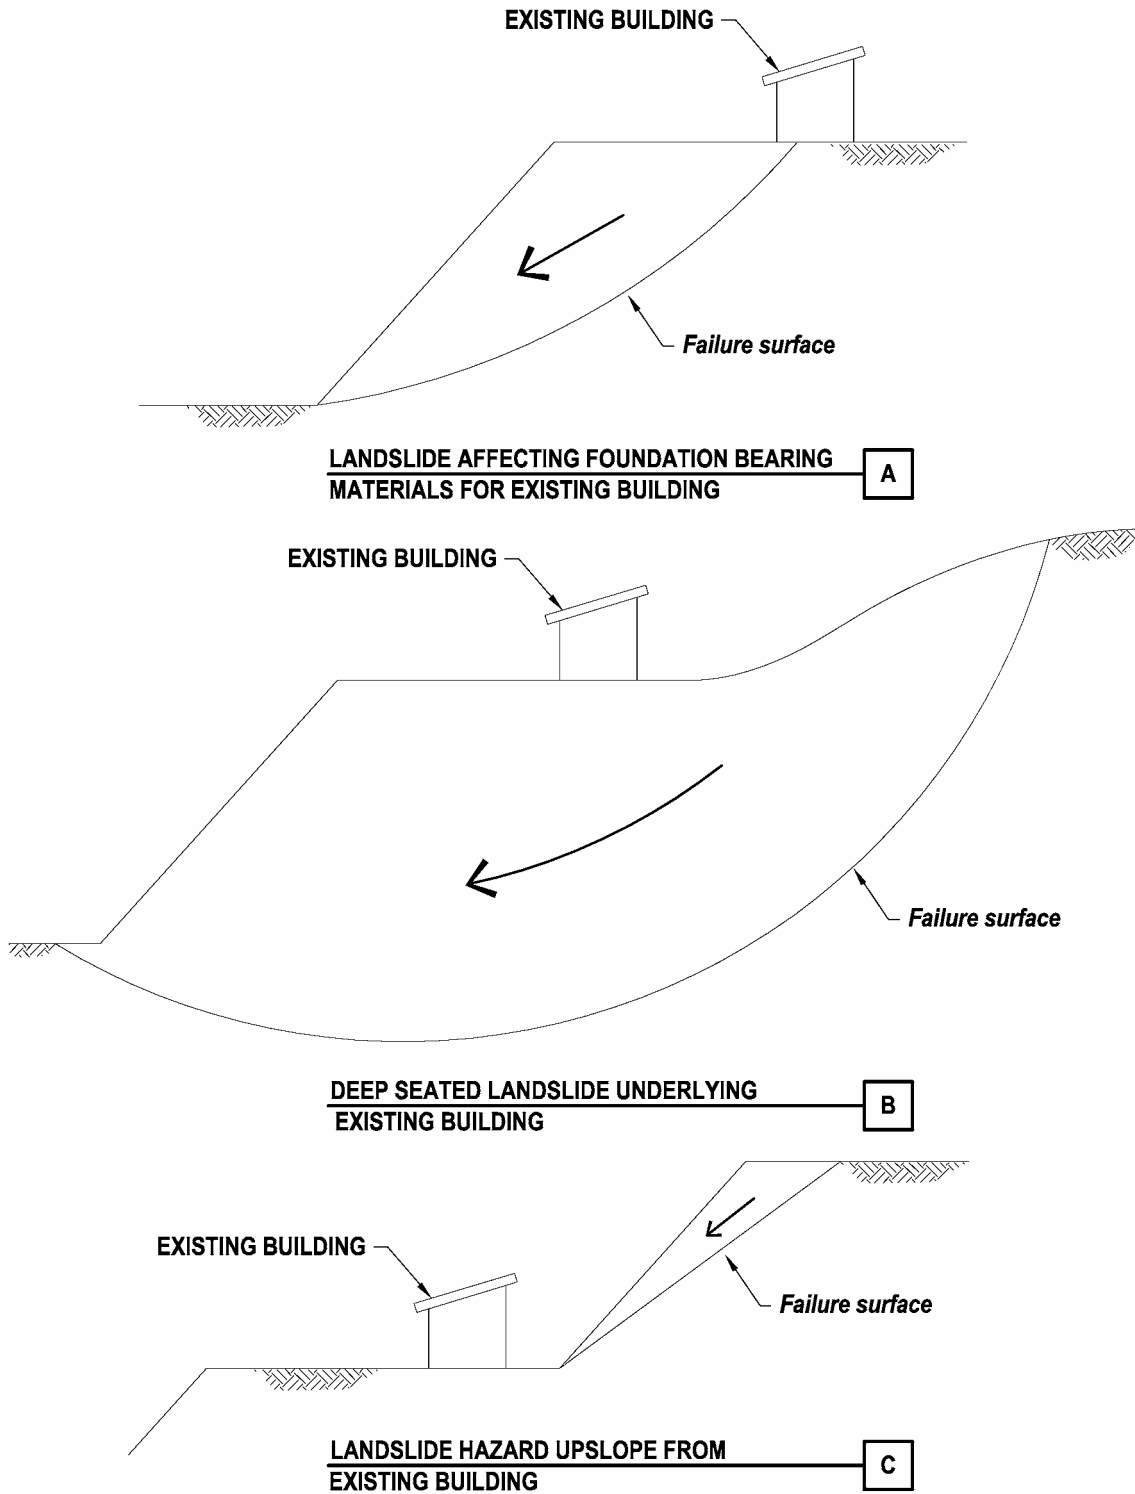
Figure 23.10.4-1: Landslide Hazards

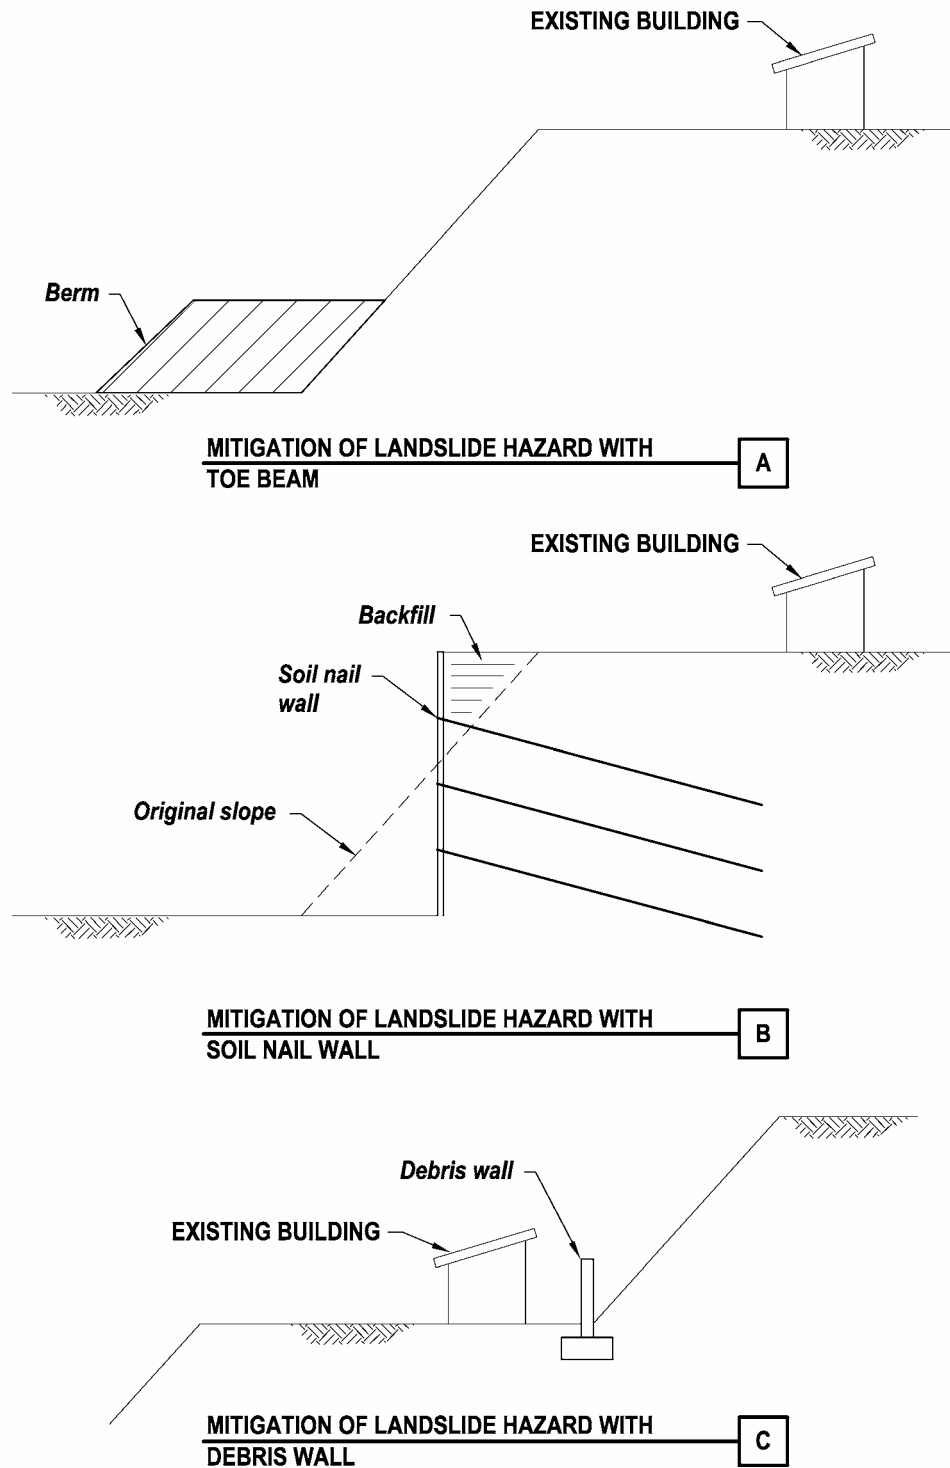
Figure 23.10.4-2: Mitigation of Landslide Hazards
