Techniques for the Seismic Rehabilitation of Existing Buildings

FEMA 547/2006 Edition

Rutherford & Chekene (R & C) Consulting Engineers (Subconsultant) under contract with National Institute of Standards and Technology (NIST).

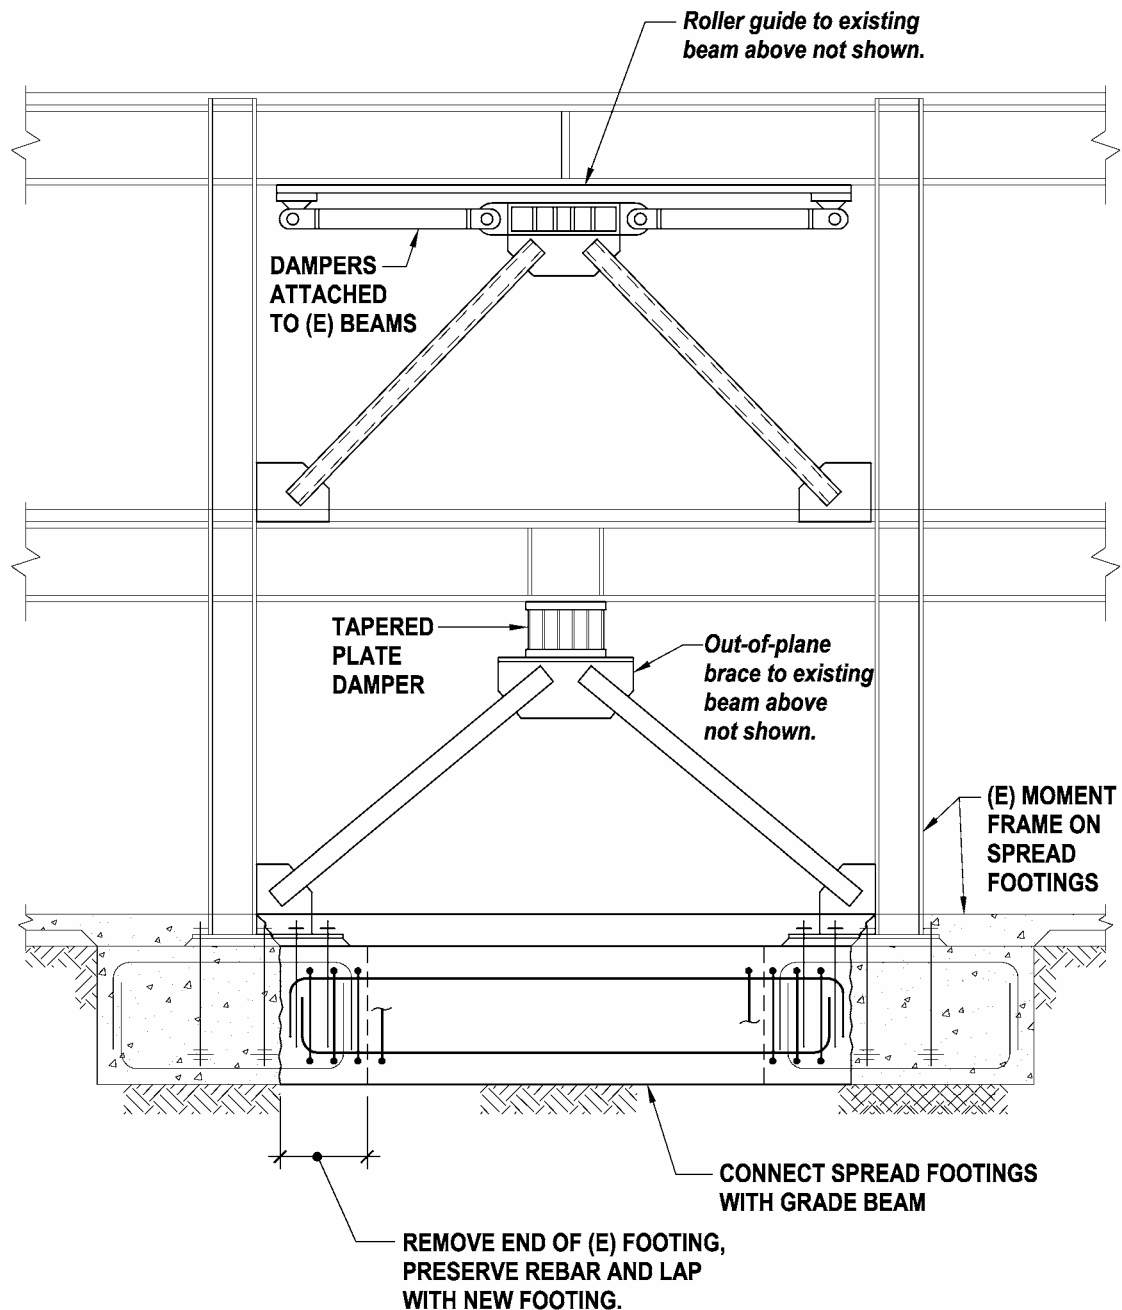
Figure 24.4-2: Additional Damper Alternatives for Rehabilitating an Existing Moment Frame
